# Evaluation of the I-94 Corridor from the Indiana State Line to US-127 South

FINAL REPORT

October 26, 2015

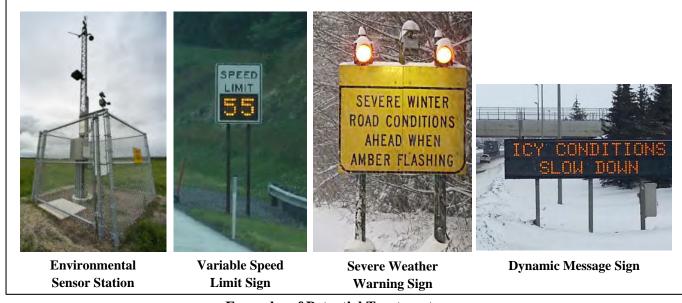
**Examples of Potential Treatments**

- Winter Weather Treatments
  - Environmental sensor stations
  - Variable speed limits
  - ITS devices providing weather-related messages
  - Advanced de-icing strategies
  - Living snow fence (strategic planting of roadside vegetation)
- Pavement Surface Treatments
  - o Resurfacing
  - High friction course
- Visibility Enhancements
  - o Signing
  - Pavement markings
  - o Delineation
  - o Lighting
- Geometric Improvements
  - Cable barrier relocation
  - Ramp extension or realignment
  - Shoulder widening
  - Increased superelevation

- Congestion Management
  - Crash investigation pull-off site
  - Courtesy patrol
  - o Incident management improvements
  - ITS devices providing queue warning messages
  - Add third lane

- Winter Weather Treatments
  - Environmental sensor station (Figure 26a)
  - Variable speed limits (Figure 26b)
  - o ITS devices providing weather-related messages (Figure 26c,26d)
  - o Advanced de-icing strategies
  - Living snow fence (strategic planting of roadside vegetation)
- Pavement Surface Treatments
  - o Resurfacing
  - High friction course
- Visibility Enhancements
  - o Signing
  - o Marking
  - o Delineation
  - o Lighting
- Geometric Improvements
  - Cable barrier relocation
  - o Ramp extension or realignment
  - Shoulder widening
  - Increased superelevation
- Congestion Management
  - Crash investigation pull-off site
  - Courtesy patrol
  - o Incident management improvements
  - o ITS devices providing queue warning messages (Figure 26c,26d)
  - Add third lane

- o Pavement markings
- o Delineation
- o Lighting
- Geometric Improvements
  - Cable barrier relocation
  - o Ramp extension or realignment
  - Shoulder widening
  - Increased superelevation
- Congestion Management
  - Crash investigation pull-off site
  - o Courtesy patrol
  - Incident management improvements
  - ITS devices providing queue warning messages (Figure 26c, 26d)
  - o Add third lane

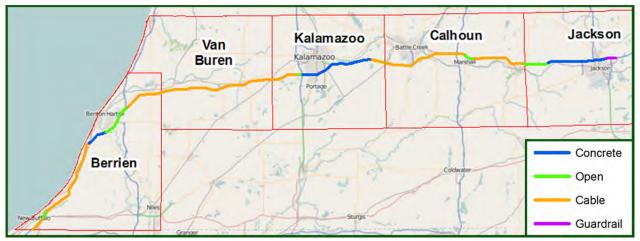
Figure 8. Median Barrier Presence, 2014

In an effort to reduce median-cross over related crashes, MDOT began installing high-tension cable median barrier on many of Michigan's freeways in 2008. This included numerous sections of I-94 in southwest Michigan, including a significant portion of the study corridor, approximately 86 miles, with the most recent sections of barrier installed in 2011. Wayne State University developed a database of these installation locations and dates, in addition to the location of other types of median barriers as a part of another MDOT project completed in 2014, the Study of High-Tension Cable Barriers on Michigan Roadways. Summary statistics for cable and other barrier installations along the study corridor is summarized in Table 7. A map depicting 2014 median presence (cable, guardrail, or concrete) is provided in Figure 8.

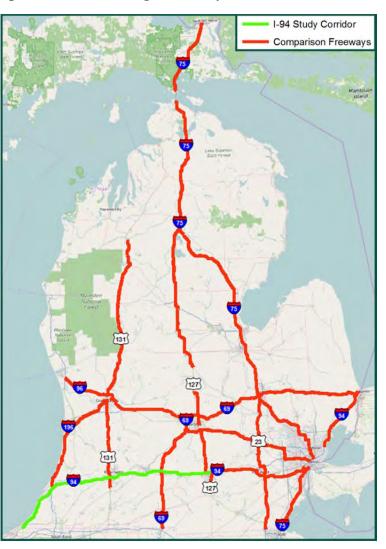
Figure 9. I-94 Study Corridor and Comparison Freeways

Prior to evaluating the safety performance observed within the I-94 study corridor, it was initially necessary to compare the crash rates between the study corridor and similar comparison freeways statewide. For the purposes of this study, the comparison freeway facilities included 70 mph sections of I-94 (exclusive of the study section), I-69, I-75 (disaggregated by the segments north of Bay County versus the segments located in Bay County and south to the state border), I-96, I-196, US-23, US-127, and US-131. A map of the comparison freeways and the study corridor is provided in Figure 9. Table 8 provides the historical traffic crash rates from 2012-2014 for the noted comparison freeway facilities.

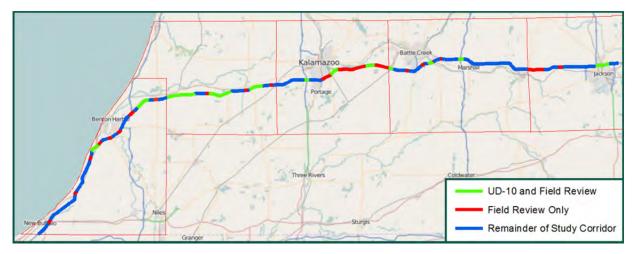
Figure 16. Overview of Safety Review Locations

The field reviews were attended by the core members of the project team, in addition to local/regional MDOT and MSP staff familiar with the corridor. The field reviews typically began with an in-office presentation of the crash concentration maps to help stimulate discussion of the primary areas for further review and possible causal factors. Anecdotal comments received prior to the meetings from local MSP and MDOT staff familiar with the corridor were also reviewed for additional insight. After identification of specific areas for further field inspection, the team then traveled the corridor and performed the on-site field reviews. Following the field reviews, the team then returned to the office for follow-up discussion to develop conclusions and possible crash countermeasures. These post-review wrap-up sessions provided substantial direction towards subsequent review of UD-10 crash reports for the primary areas of high crash concentration along corridor, which is described in the paragraphs that follow. Figure 16 provides and overview of the site review locations on the study corridor.

A subsequent review of more than 2,000 UD-10 crash report forms was performed for selected areas along the study corridor that were identified during the field reviews as areas warranting further investigation. The UD-10 reviews were intended to identify specific crash trends and recommend appropriate countermeasures. Ten freeway segments and two interchanges were selected for this detailed evaluation. Deer crashes were excluded from this review. The selected interchanges and segments for the UD-10 crash report review are summarized in Table 12 and displayed in Figure 16.

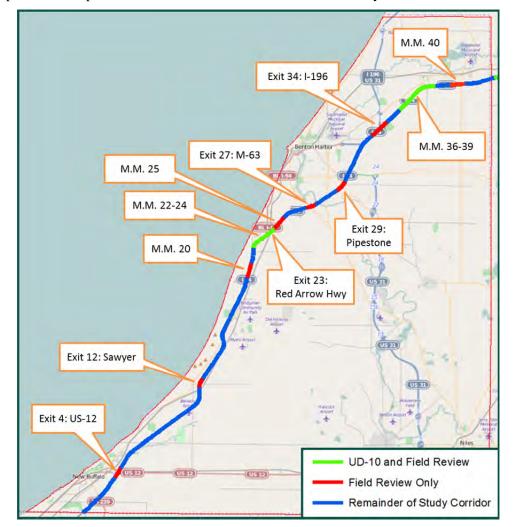
Figure 17. Safety Review Locations – Berrien County

Figure 17 presents a map of the reviewed locations within Berrien County.

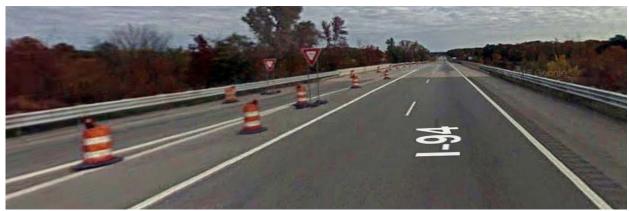
Eastbound I-94 at Entrance Ramp from Westbound US-12 (Exit 4)

control speeds and alleviate overturns. Extension of the acceleration lane or ramp reconfiguration may also be a potential safety countermeasure.

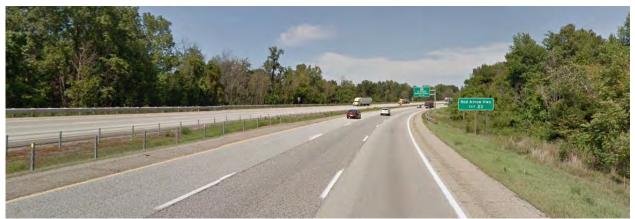
Eastbound I-94 at Puetz Road Curve

- <u>Mile Marker 22-24 (including Puetz Road curve and Red Arrow Highway Interchange [Exit 23]):</u>
  - <u>Issues Identified</u>: This area, particularly near the Red Arrow Highway interchange, contains the highest concentration of crashes along the entire study corridor. This is especially the case in the eastbound direction near the entrance ramp from Red Arrow Highway, where truck-involved crashes are greatly overrepresented compared to all other locations along the study corridor. Crashes were found to frequently occur downstream of the eastbound entrance ramp, possibly due to truck acceleration issues and/or sight distance issues caused by the crest vertical curve prior to the entrance ramp. The interchange issues are compounded by the nearby horizontal curve at Puetz Road, which possesses the lowest design speed (between 70 mph and 75 mph) of any horizontal curve on the study corridor. The UD-10 review of this area found approximately half of the crashes to have occurred during wintry road surface conditions.

area for vehicles. The recently installed median cable barrier will help prevent the often severe cross-median type crashes that had previously occurred in the area. Property damage crashes may also be reduced if the cable median barrier is relocated away from the eastbound shoulder through the Puetz Road curve. However, cable barrier relocation may not be possible in the interchange area due to the reduced median width. To combat winter weather safety issues, this section may benefit from installation of an environmental sensor station and corresponding ITS signs/devices to alert motorists when poor weather and/or surface conditions are predicted. Additionally, a "living snow fence" consisting of dense installation of trees and other vegetation, similar to that proposed between Exits 46 and 56, may help reduce the occurrence of blowing and drifting of snow across open sections of the freeway. Advanced salting techniques, including brine or other chemicals or methods, may help improve winter road conditions along this section. Although a long-term implementation strategy, improvements to the freeway lighting, particularly at the interchange, may provide additional safety benefits.

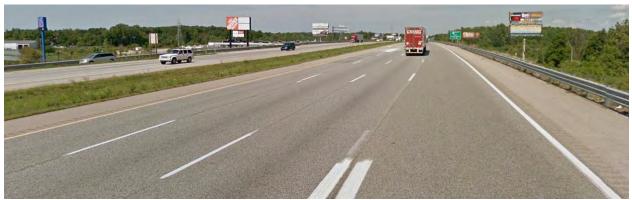
Eastbound I-94 Entrance Ramp from Pipestone Road (Exit 29)

- Exit 29 (Pipestone Road): The eastbound entrance ramp involves both a vertical upgrade and horizontal curve with an abrupt merge taper. These collectively create acceleration issues, particularly for trucks. The eastbound auxiliary lane extension to the next interchange (Napier Road) is a possible medium to long term improvement.

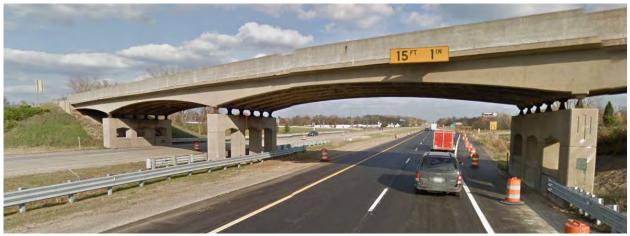
Eastbound I-94 Exit Ramp at Exit 39 (Friday Road)

- Mile Marker 36-39 (including Friday Road Interchange [Exit 39] and adjacent curve):
  - <u>Issues Identified</u>: This is an area of relatively high crash concentration, both eastbound and westbound, particularly for winter crashes and overnight crashes. The UD-10 review revealed that nearly one-half of crashes occurred under wintry or wet pavement surface conditions. Blowing snow is known to frequently occur between mile markers 36 and 38. Geometric issues also persist along this portion of the study corridor. The Friday Road curve leads into eastbound exit ramp, which includes a very short tapered deceleration lane just beyond the Friday Road overpass and in advance of a sharply curved loop ramp. Although this ramp meets the minimum geometric standards, run-off-the-road crashes still occur along the curved portion of this ramp. Advance ramp speed signs were previously placed in order to warn traffic of the approaching

strategy, improvements to the freeway lighting, particularly at the interchange, may provide additional safety benefits. Relocating the cable median barrier away from the eastbound shoulder through the Friday Road curve should reduce the occurrence of median barrier collisions, while still inhibiting cross-median crashes.

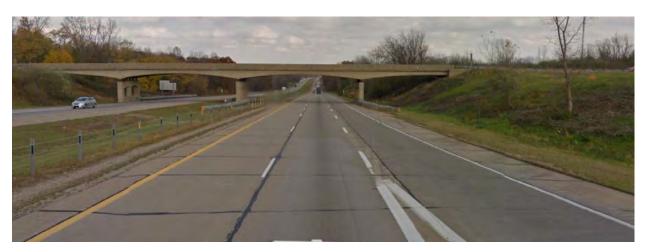
Entrance Ramp to Eastbound I-94 at Exit 52 (CR 365)

• Exit 52 (CR 365): Eastbound I-94 includes substantial vertical downgrade near the entrance ramp leading into a bridge underpass. This may be a suitable location for high friction surface, which is particularly effective during winter road conditions.

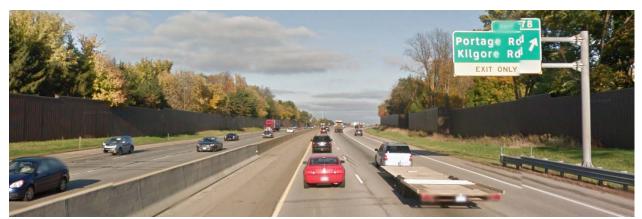
Eastbound Approaching Exit 78 (Portage Road)

• Mile Marker 77-78 (including Portage Road Interchange [Exit 78]): Safety issues may exist due to the unusual condition where the I-94 eastbound right lane becomes the Portage Road exit ramp. MDOT has installed "Exit Only" pavement markings and will be installing a large cantilever sign to inform drivers of the pending exit ramp and subsequent lane drop. Also, the low friction on the new concrete pavement between Oakland and Lovers should be reviewed. The eastbound entrance ramp from Southbound Portage Road has a relatively short acceleration lane. It is recommended that MDOT review the current design to determine if the lane can be lengthened into the northbound Portage Road entrance ramp.

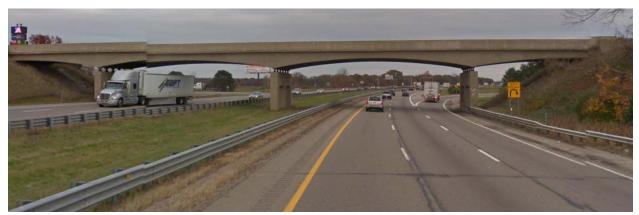
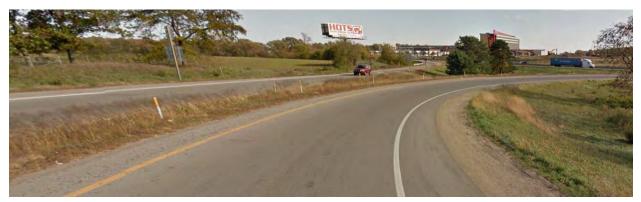
• Exit 104 (M-96/11 Mile Road): Both the eastbound and westbound exit ramps to 11 Mile Road have recently been extended to account for the increased traffic associated with the casino. Two truck stops also exist on the north side of the interchange. The eastbound loop ramp has tight horizontal radii and is particularly susceptible to backups. Truck rollover crashes is a major issue on the westbound entrance ramp. However, the bridge will require replacement in the event of westbound entrance ramp realignment. Cross-hatching or other delineation treatments should be implemented in the gore area. Safety improvement projects are scheduled for this interchange in 2020 to correct the superelevation difference with the mainline.

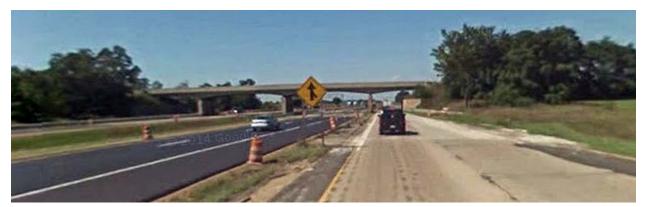
Westbound I-69 Entrance Ramp to Westbound I-94 Collector-Distributor Road

Potential Countermeasures: A living snow fence should be considered to inhibit blowing 0 snow. I-69 SB to I-94 Westbound presents a particularly precarious merge area between the ramp and the collector-distributor road, with the 15 Mile Road bridge abutment at the end of the merge taper, which contributes to a relatively high occurrence of side-swipe collisions. A potential long-term solution is to improve the merging area at this location, which would require reconstruction of the 15-mile Road Bridge. Furthermore, the eastbound I-94 crash attenuator at the I-69 exit ramp is struck several times each year. Delineation improvements have recently been installed within the eastbound exit gore area. Speed-related truck rollover crashes have been a longstanding problem on the loop ramps at this interchange. A subsequent signing/delineation project in late 2012 was performed to help correct this issue. This project included the addition of advisory speed signs, chevrons with reflective sheeting on posts, and truck rollover signs to all ramps. Increasing the superelevation of the loop ramps is a possible countermeasure to increase the ramp design speed. Additional enhancements to roadside delineation throughout the mainline and interchange will be performed as part of the 2016 I-94 Calhoun County signing upgrade project. An environmental sensor station is proposed to be built within the I-69 interchange in 2016, which will provide real time pavement condition data as well as support roadway condition forecasting with atmospheric sensors. This should improve winter maintenance and help alleviate weather related safety and operational issues, particularly if this data is used along with ITS devices to alert motorists of changing weather and/or pavement conditions. Advanced salting techniques, including brine or other chemicals or methods, may also help improve winter road conditions along this section. Although a long-term implementation strategy, improvements to the freeway lighting may provide additional safety benefits.
