# Maintenance Practices and Costs of Rail-Trails

## *Produced by Rails-to-Trails Conservancy*

**June 2015**

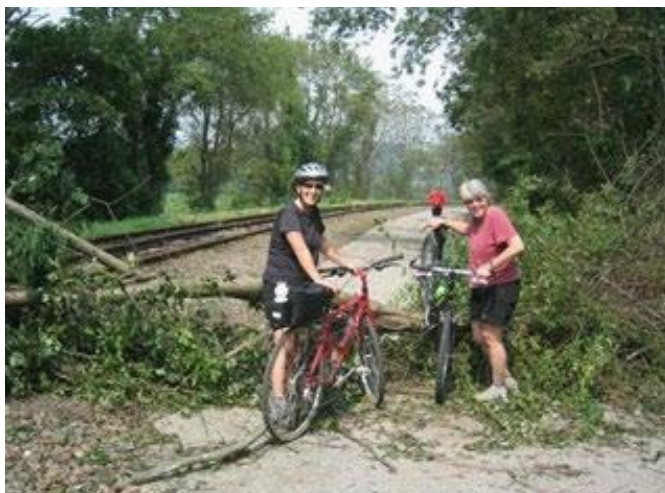
Tree down on Heritage Rail Trail County Park, PA.

Tree removal was a significant maintenance task reported in our detailed maintenance cost analysis survey. Most of the reported costs were in excess of \$1,000. Forty percent of the reporting trails indicated that they contracted out this activity. There are a number of reasons stated for removing trees. In some cases storms cause trees to block the trail. In others, a dead tree presents a potential hazard to trail users and is removed before limbs come crashing down on the trail.

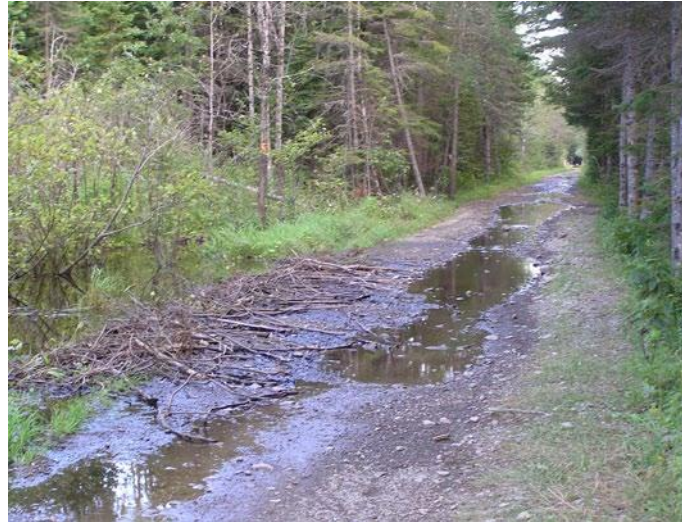
Beaver caused erosion damage, Ashuelot Rail-Trail, NH.

Not only did these costs vary widely across our sample, but they also varied widely from year to year. The major cause of damage to non-asphalt trails was because of water erosion, as reported by 55 percent of survey respondents.

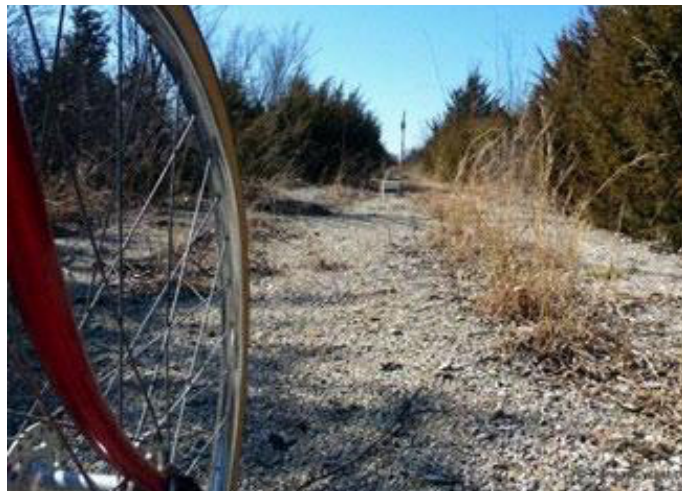
Uncontrolled weed growth through trail surface.

The second biggest cause for repairs is because of vegetation, as reported by 25 percent of survey respondents. This can be caused by grass growing through non-asphalt trail surface, vegetation encroaching on trail edges or proliferation of invasive species. Controlling damage caused by vegetation encroachment is manageable with a program of regular, scheduled inspection and preventative maintenance.

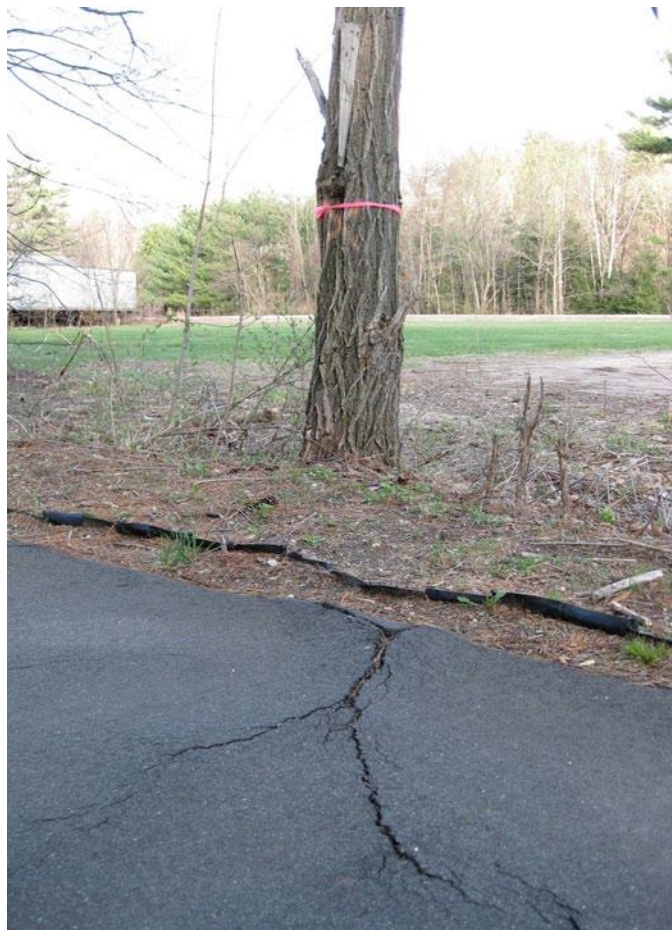
**Tree root damage Manhan Rail Trail, MA.**

More than 60 percent of asphalt trail managers reported tree roots as the major source of trail damage. Clearly, as more asphalt trails are being built rather than stone dust trails (as required by some departments of transportation and metropolitan planning organizations); the true costs of these facilities needs to be better understood and shared. Replacing asphalt after several years is costly and frequently becomes a rebuild that is often funded by Transportation Enhancement (TE) programs or Transportation Alternatives Programs (TAP). This costly maintenance requirement might be prevented with better construction standards and possible use of root barriers in certain segments of a trail or periodic trenching to cut root growth. The removal of healthy trees several years after the trail is built is not the only option.

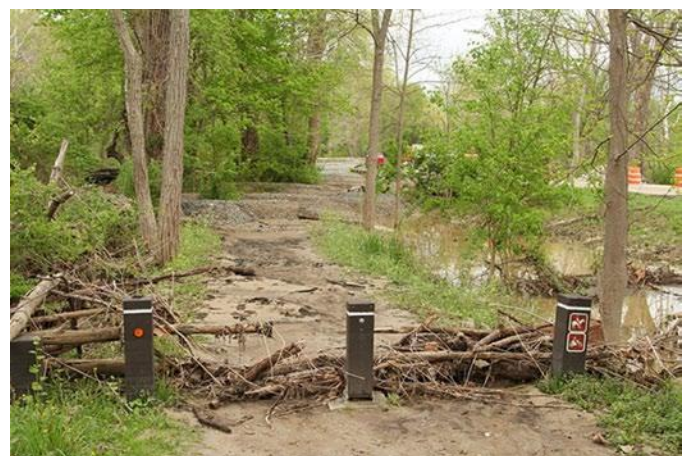
**Erosion damage to stone dust trail.**

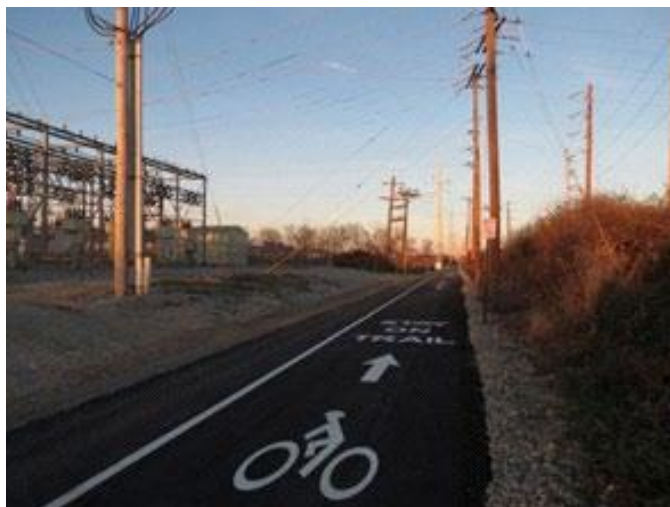
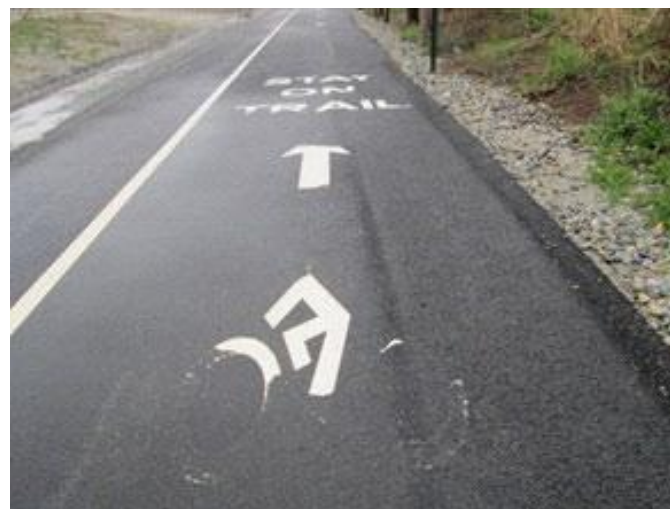
Pavement markings, Hanover Trolley Trail, PA.

Pavement markings are generally associated with asphalt-surfaced trails. This study found that a painted center line was the most common type of pavement marking. Other pavement markings are safety or instructional in nature. Some markings are painted on the trail surface, while others are applied thermally. The detailed cost analysis revealed that this activity, while not reported by many respondents, varied in cost from \$19 per mile to \$140 per mile.

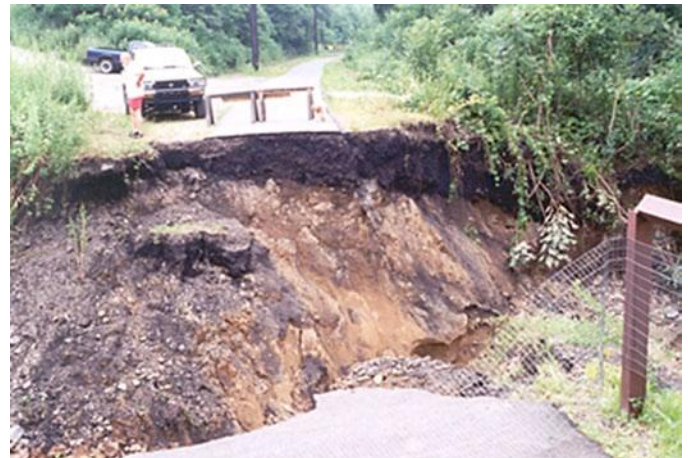
Culvert failure, Allegheny River Trail, PA.

Periodically investing several hundred or even several thousand dollars in maintaining trail drainage systems and culverts can prevent catastrophic damage to a trail when a major water event occurs.

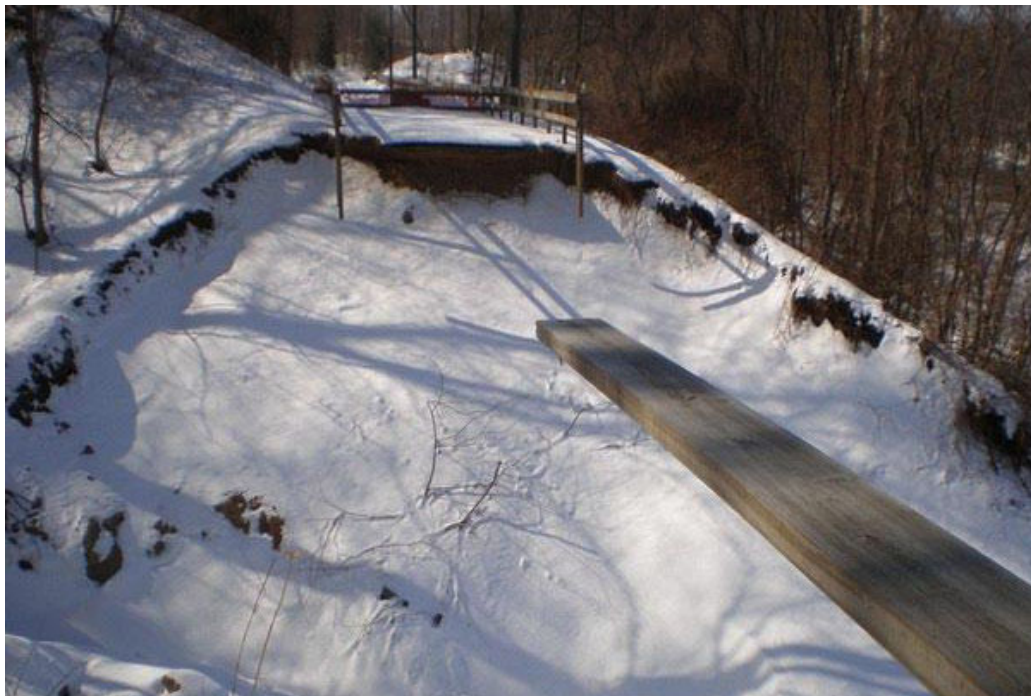
Culvert failure, Manhan Rail Trails, MA.

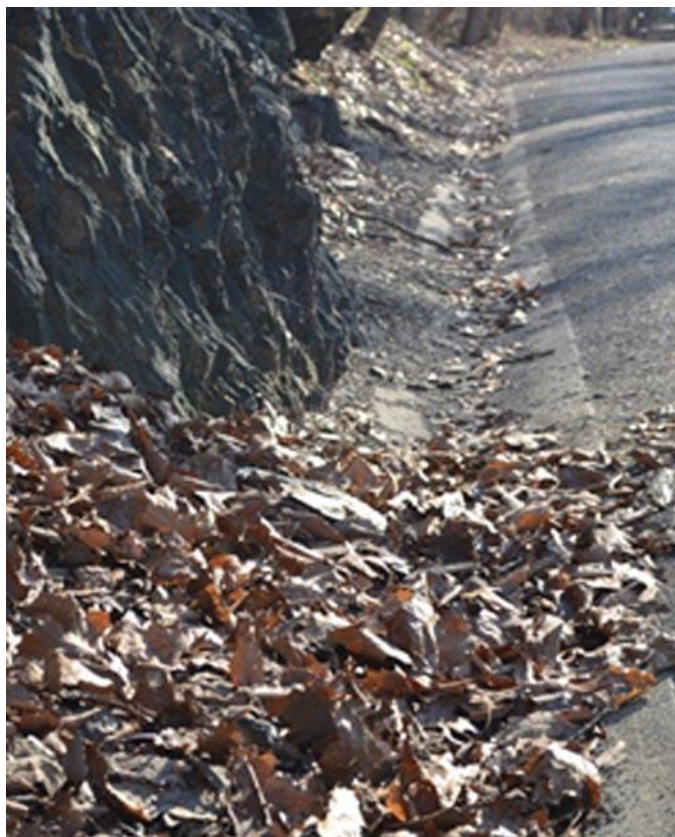
**Drainage swale in need of cleaning.**

The West Penn trail maintenance plan calls for clearing drainage swales twice a year or as needed. Most of this work is done with rakes and shovels. Some larger ditches may require the use of a backhoe.

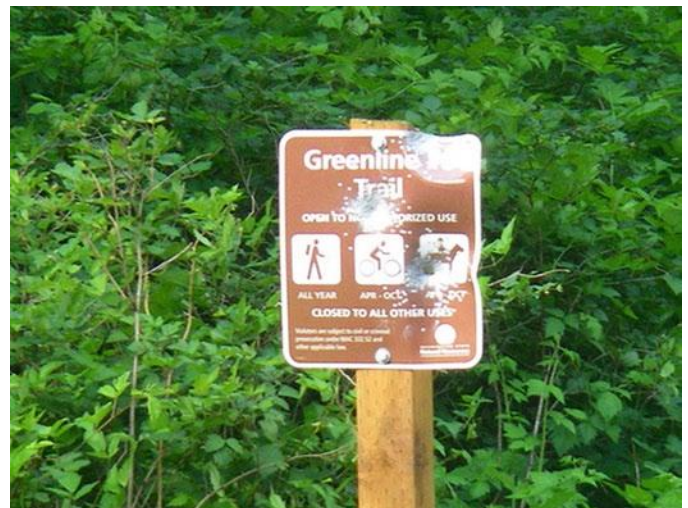
Greenline Trail sign used for target practice.

More than 75 percent of the respondents to the general maintenance survey reported that vandalism was the major cause of damage requiring signage repair and maintenance.

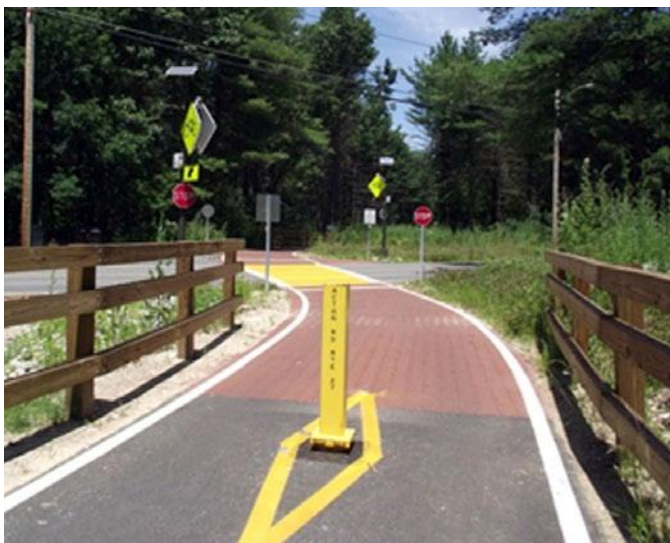
Bollard at intersection, Bruce Freeman Rail Trail, MA.

Gates and bollards are used to keep automobiles and other motorized vehicles off of trails that are intended only for non-motorized use. While maintenance costs associated with gates and bollards were reported by only 15 percent of detailed cost analysis respondents, most indicated costs of between \$2,300 and \$5,000.

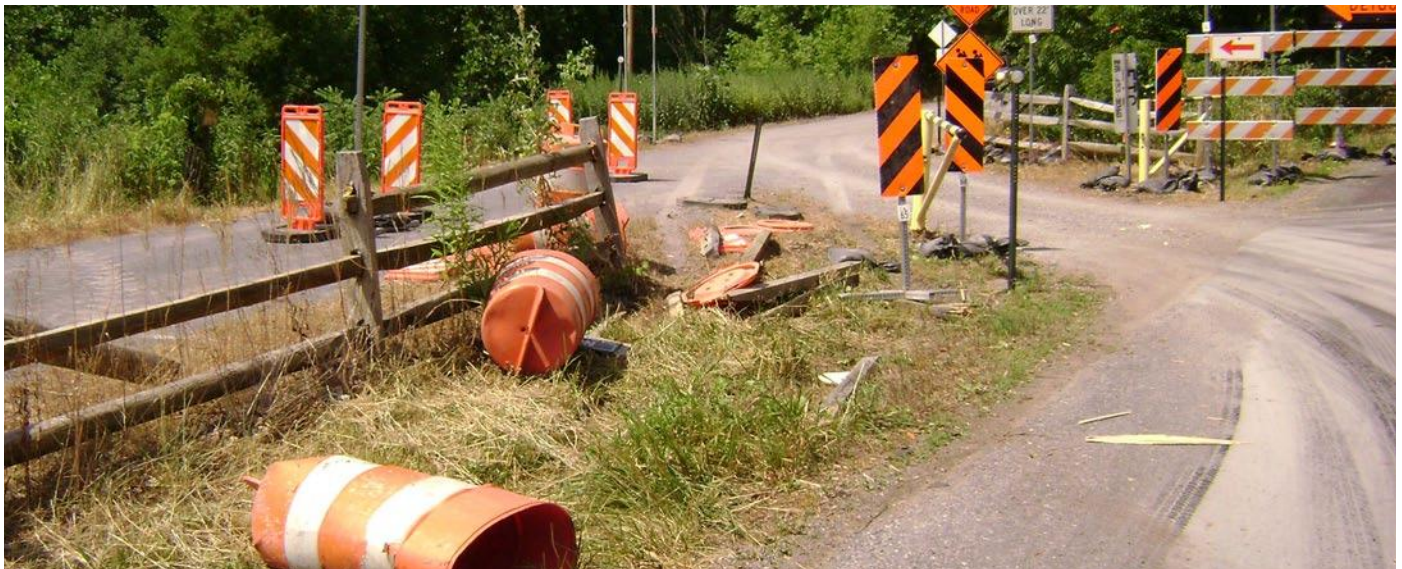
Damaged split rail fence along the Pine Creek Rail Trail, PA.

Of these three types, wooden fencing was reported to require the most maintenance. Thirty percent of the detailed cost survey respondents reported time repairing wooden fencing. This maintenance can take the form of replacing fencing that had rotted or fencing that had been damaged by accident or acts of vandalism. Only 8 percent of respondents reported repairs to chain link fence. No respondents reported repairs to vinyl fencing.
