**JACKSON AREA COMPREHENSIVE TRANSPORTATION STUDY (JACTS)
TECHNICAL ADVISORY COMMITTEE**

Evaluation of the I-94 Corridor from the Indiana State Line to US-127 South

FINAL REPORT

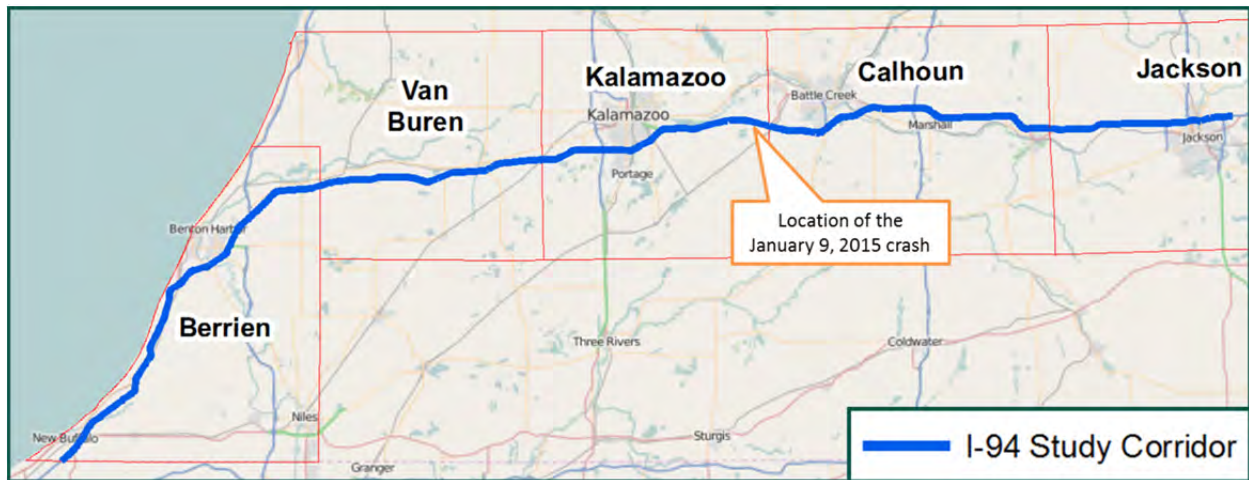
I-94 Study Corridor in Southwest Michigan

In the wake of this major crash event, State Senator Margaret O'Brien submitted a letter to the Michigan Department of Transportation (MDOT), which was followed by a subsequent inquiry from Governor Rick Snyder, regarding the safety of I-94 in eastern Kalamazoo County. Shortly thereafter, MDOT committed to a safety evaluation of the I-94 corridor between the Indiana border and US-127 South in Jackson County. The decision to expand the corridor boundaries was largely due to MDOT's concern with the occurrence of major crashes in the prior year and associated extensive freeway closure durations. Approximately 143 continuous miles of I-94 were included within this study, including all sections of the corridor in Berrien, Van Buren, Kalamazoo, Calhoun, and the western portion of Jackson County, as displayed in the figure below.

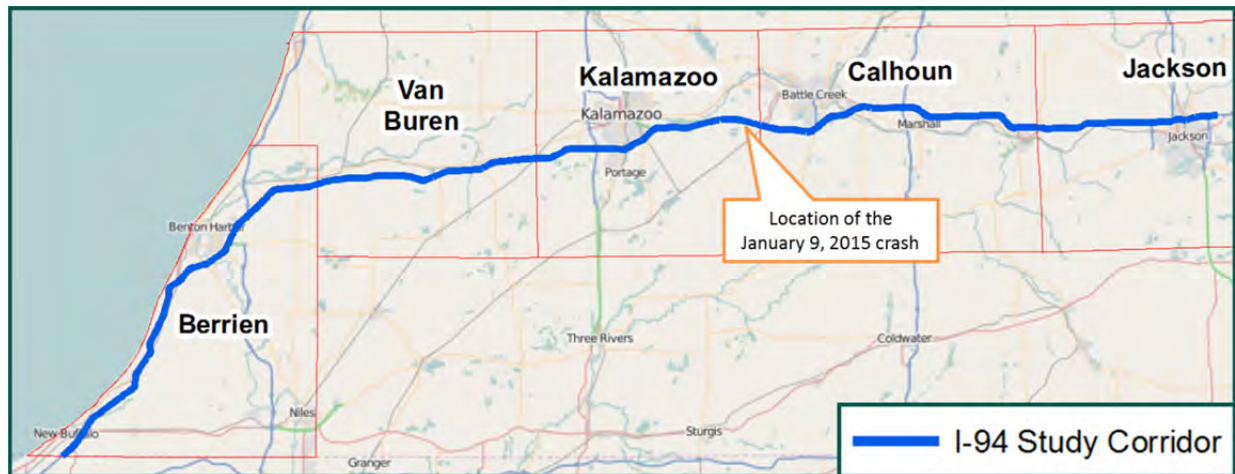
Figure 1. I-94 Study Corridor in Southwest Michigan

In the wake of this major crash event, State Senator Margaret O'Brien submitted a letter to Michigan Department of Transportation (MDOT), which was followed by a subsequent inquiry from Governor Rick Snyder, regarding the safety of I-94 in eastern Kalamazoo County. Shortly thereafter, MDOT committed to a safety evaluation of the I-94 corridor between the Indiana border and US-127 South in Jackson County. The decision to expand the corridor boundaries was largely due to MDOT's concern with the occurrence of major crashes in the prior year and associated extensive freeway closure durations. Overall, the portion of the corridor included in this study was comprised of approximately 143 miles of freeway in each direction of travel, for a total of 286 directional freeway miles. The section of the I-94 corridor that was included in this study is shown in Figure 1 below.

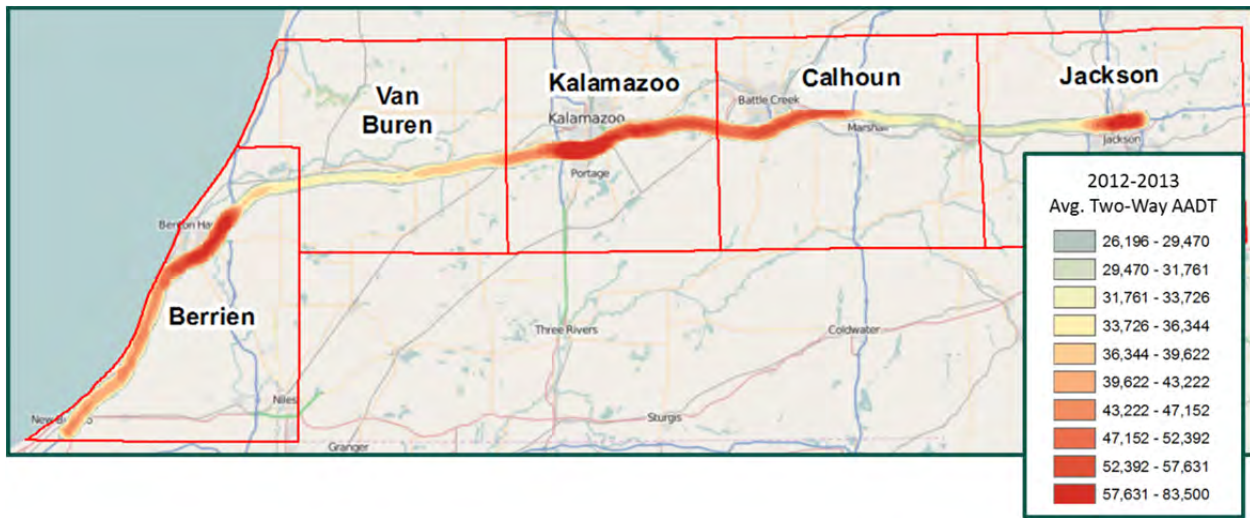
Figure 2. I-94 Study Corridor AADT, 2012-2013

Several available attributes from the sufficiency file are summarized in Table 1. Mean annual average daily traffic (AADT) and commercial annual average daily traffic (CAADT) volumes for the study corridor are displayed in greater detail in Figures 2 through 4 as well as Appendix B. It can be observed from Table 1 that AADT was substantially higher than the corridor average in Kalamazoo County and substantially lower in Van Buren County. Commercial AADT was also highest in Berrien County and lowest in Van Buren County.

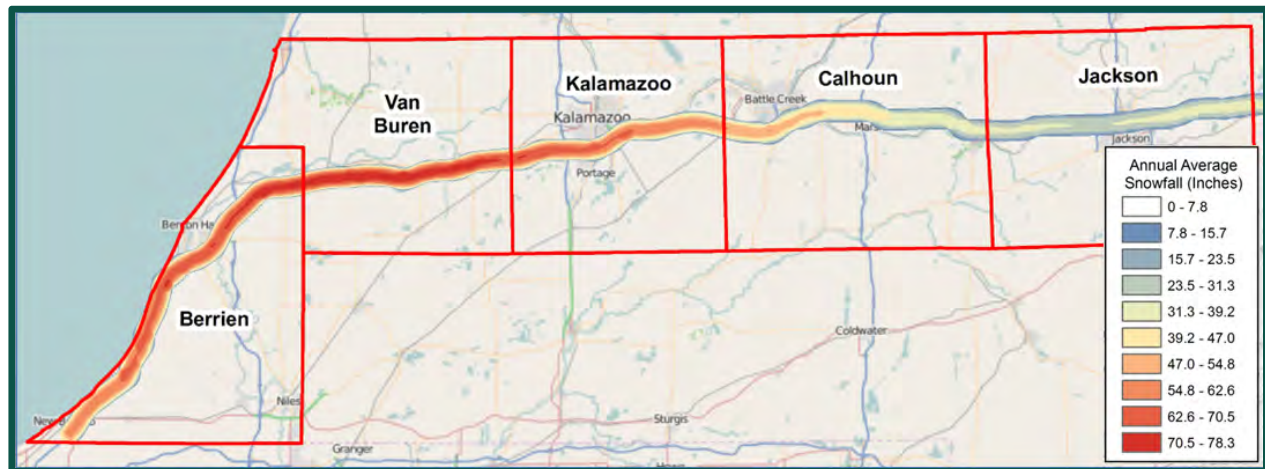
Figure 6. Corridor Average Annual Snowfall, 2012 – 2014

beginning to diminish east of US-131 in Kalamazoo County and further diminishing east of I-69. The greatest average countywide snowfall totals occurred in Van Buren County, followed closely by Berrien and Kalamazoo Counties. Calhoun and Jackson Counties observed much lower average snowfall totals. In particular, Jackson County experienced less than one-half of the average snowfall experienced by Van Buren, Berrien, and Kalamazoo Counties between 2012 and 2014. Table 3 also suggests relatively consistent average annual precipitation and temperatures along the corridor.

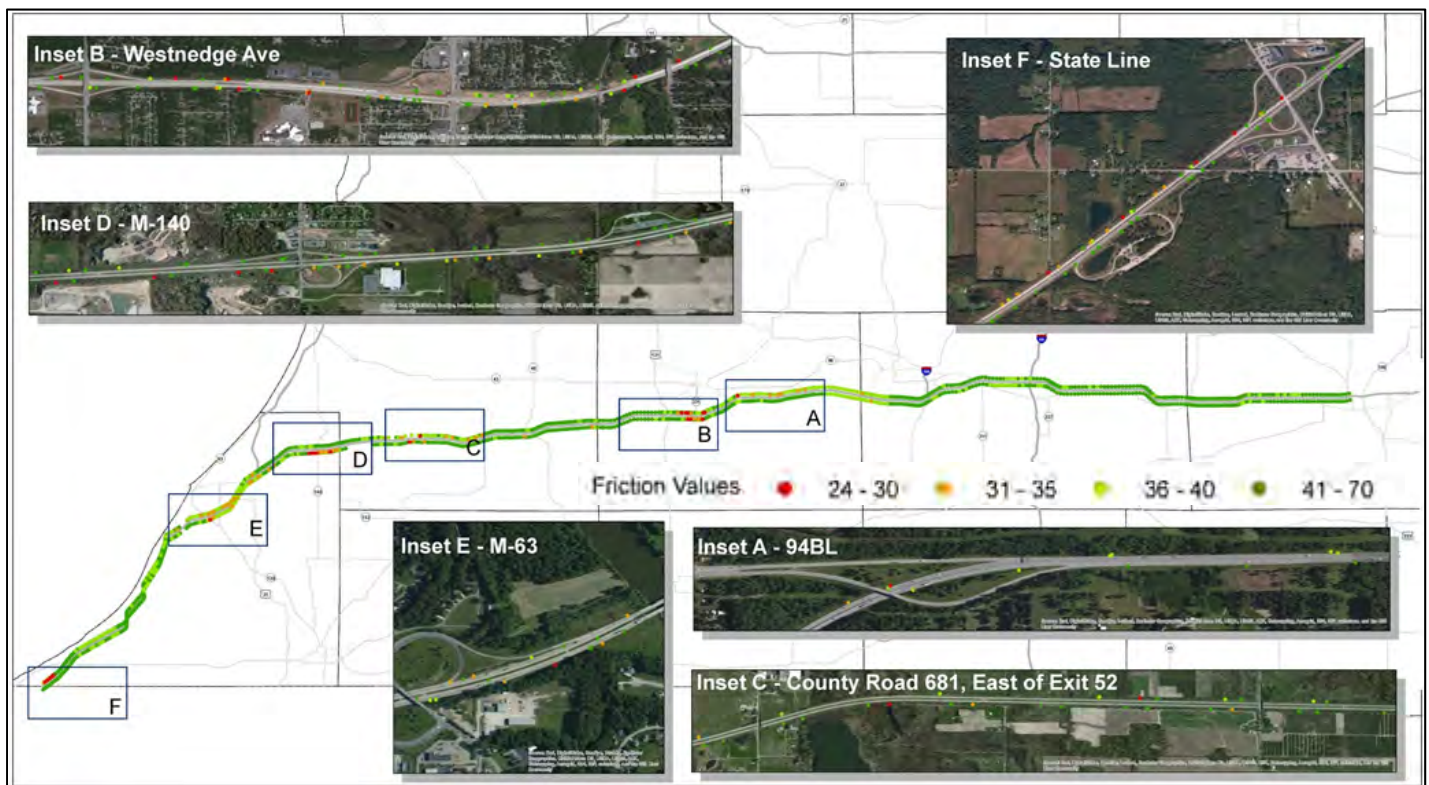
Figure 7. MDOT Friction Values, 2013-2014

- Berrien County
 - WB near mile marker 1
 - EB near M-63 Exit (mile marker 27)
 - EB near M-140 Exit (mile marker 39-40)
- Van Buren County
 - EB/WB near mile marker 49-50
- Kalamazoo County
 - EB/WB Westnedge to Lovers (mile marker 76-77)
 - WB near I-94BL (mile marker 81)

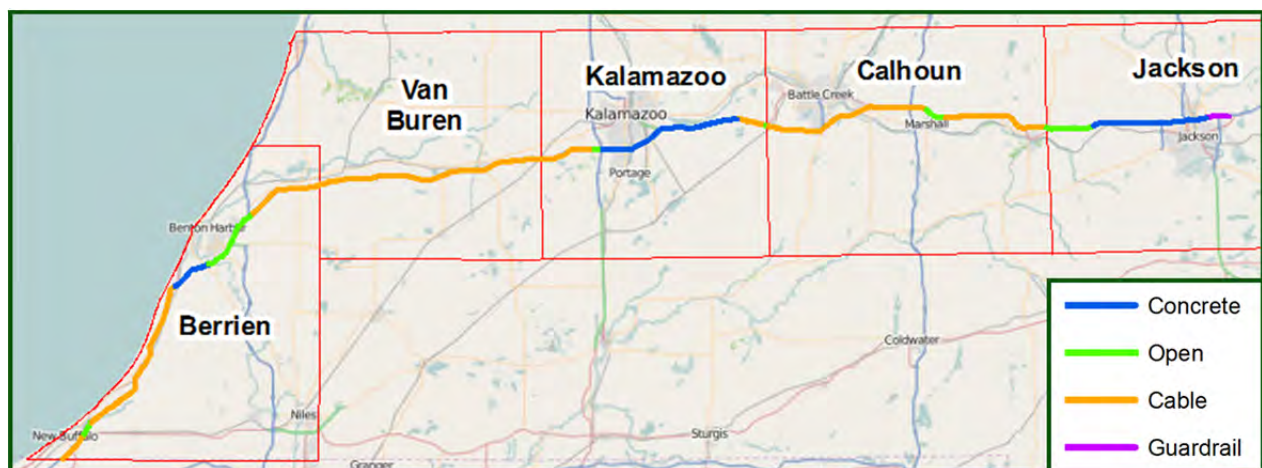
Figure 8. Median Barrier Presence, 2014

*Berrien County cable barrier coverage was nearly 100 percent at the time of this report.

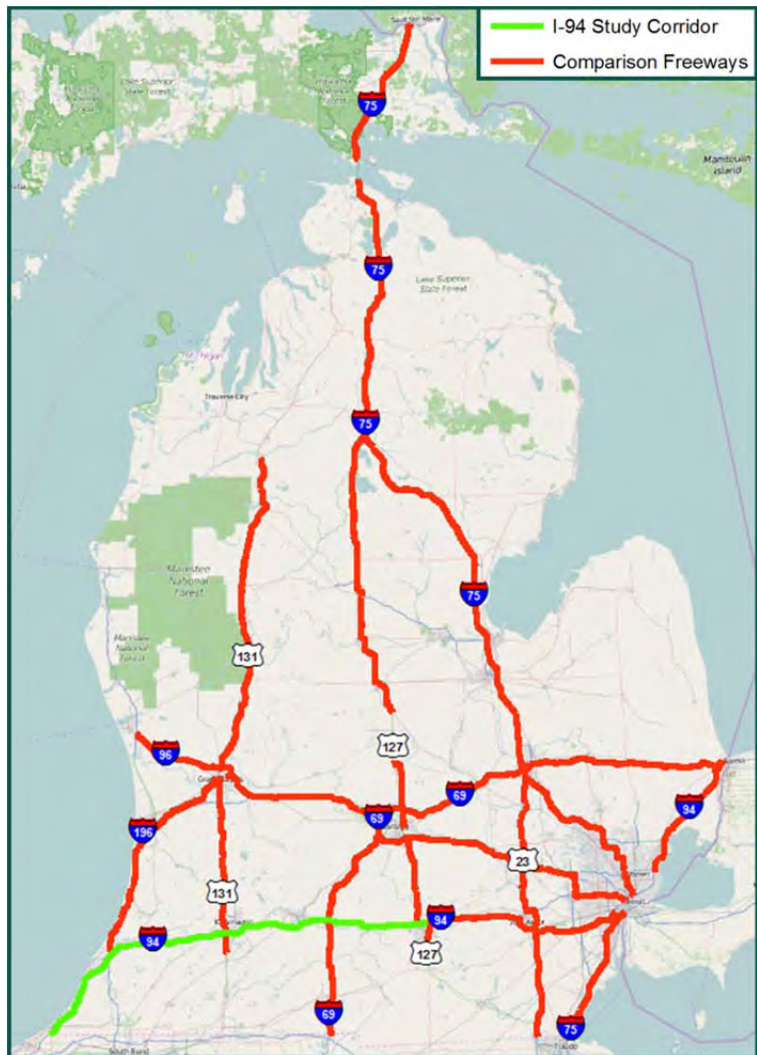
Figure 9. I-94 Study Corridor and Comparison Freeways

Prior to evaluating the safety performance observed within the I-94 study corridor, it was initially necessary to compare the crash rates between the study corridor and similar comparison freeways statewide. For the purposes of this study, the comparison freeway facilities included 70 mph sections of I-94 (exclusive of the study section), I-69, I-75 (disaggregated by the segments north of Bay County versus the segments located in Bay County and south to the state border), I-96, I-196, US-23, US-127, and US-131. A map of the comparison freeways and the study corridor is provided in Figure 9. Table 8 provides the historical traffic crash rates from 2012-2014 for the noted comparison freeway facilities.

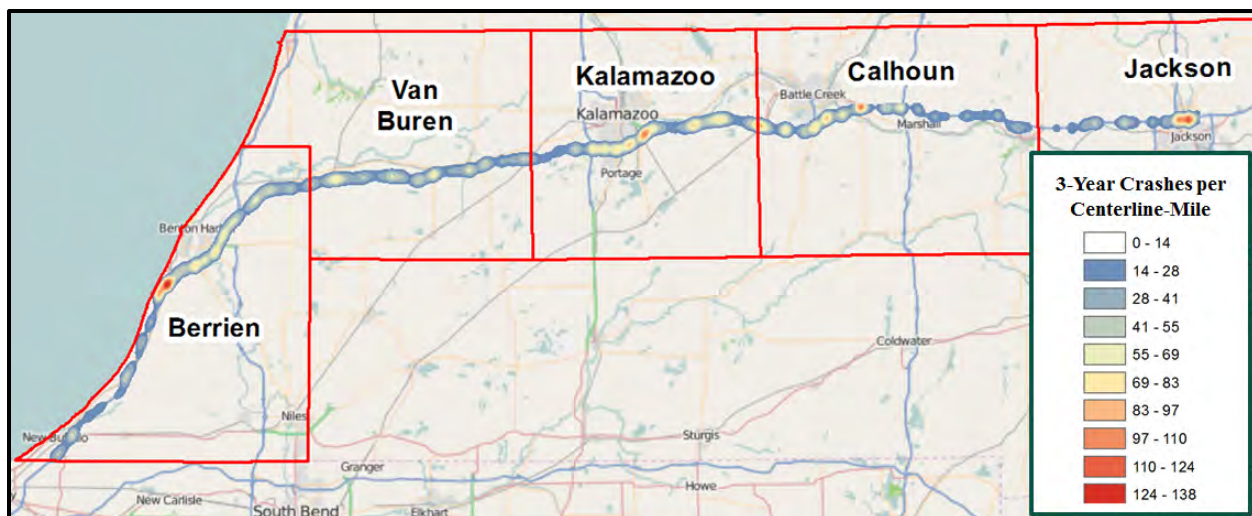
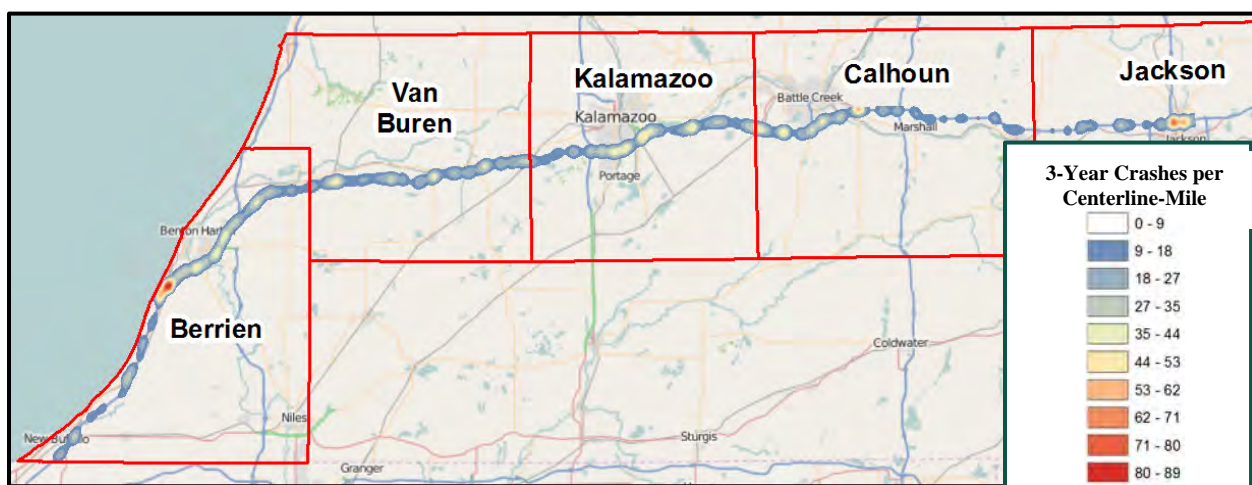
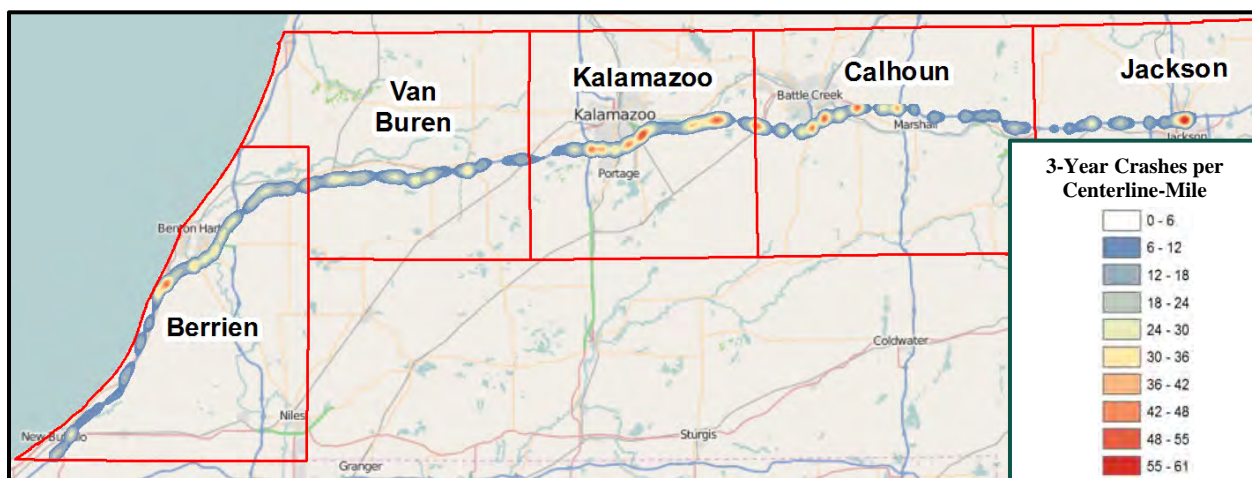
Figure 10 displays the concentration of total crashes, exclusive of deer-involved, along the corridor for the three-year period between 2012 and 2014. These data are displayed both overall (10A) and independently by direction (10B and 10C). The corridor directional crash rates are also provided for the in Figure 11.

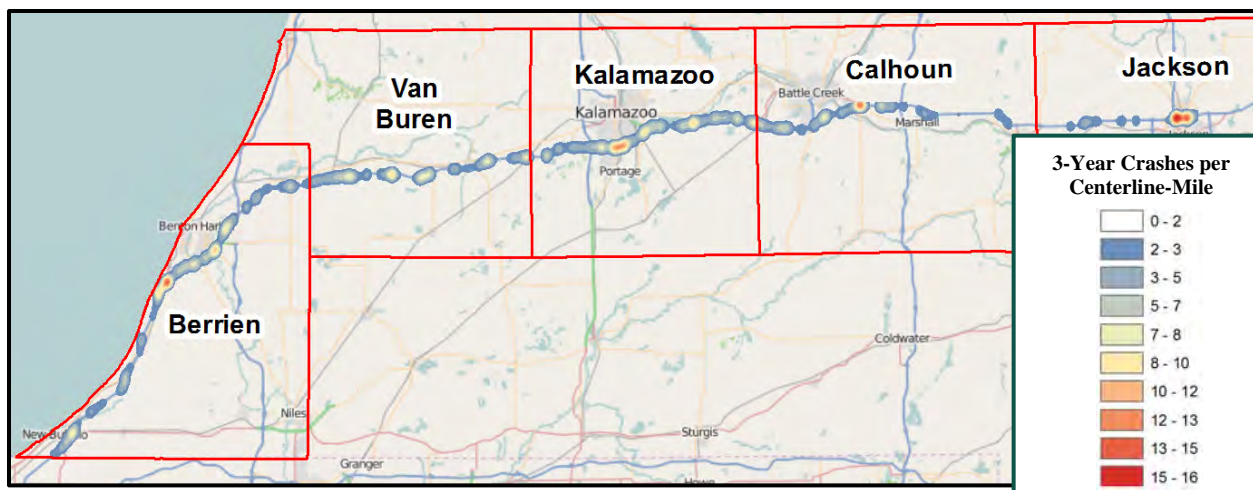
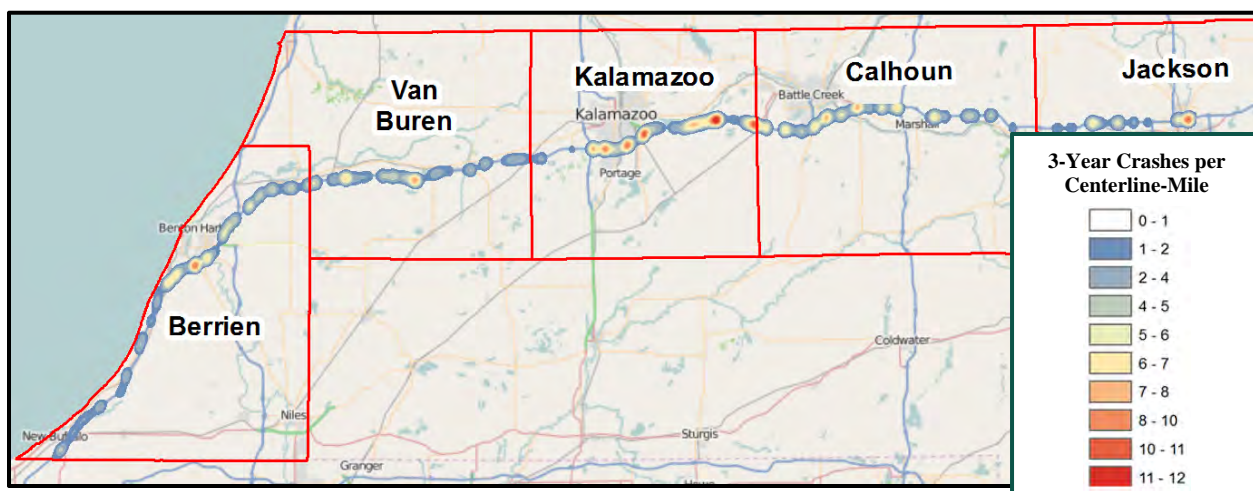
In addition to total crashes, it was also necessary to investigate injury crashes. Figure 12(A) and (B) displays the relative corridor crash occurrence for injury crashes (inclusive of fatal crashes) for the three-year period between 2012 and 2014.

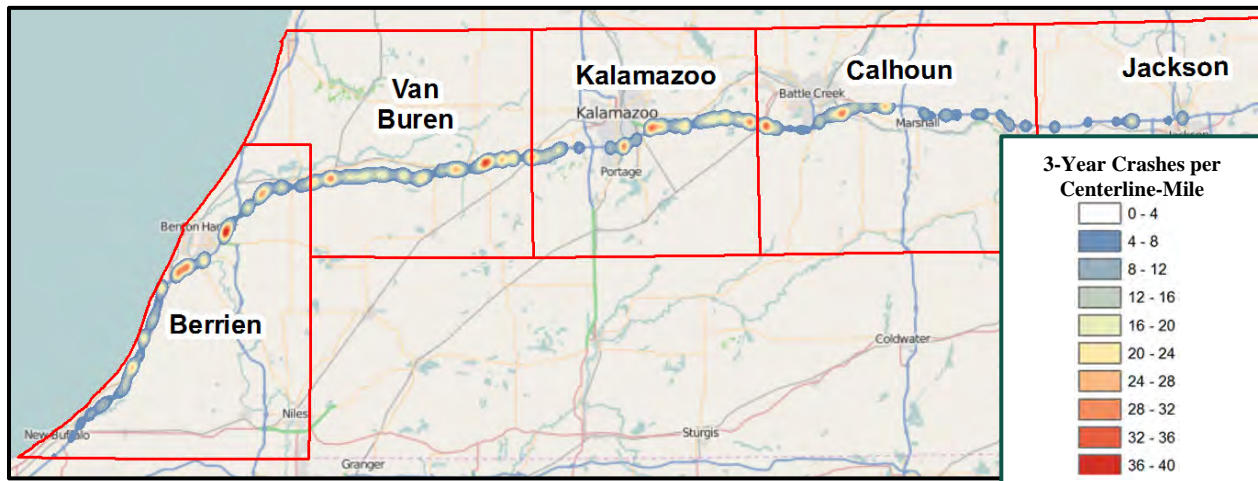
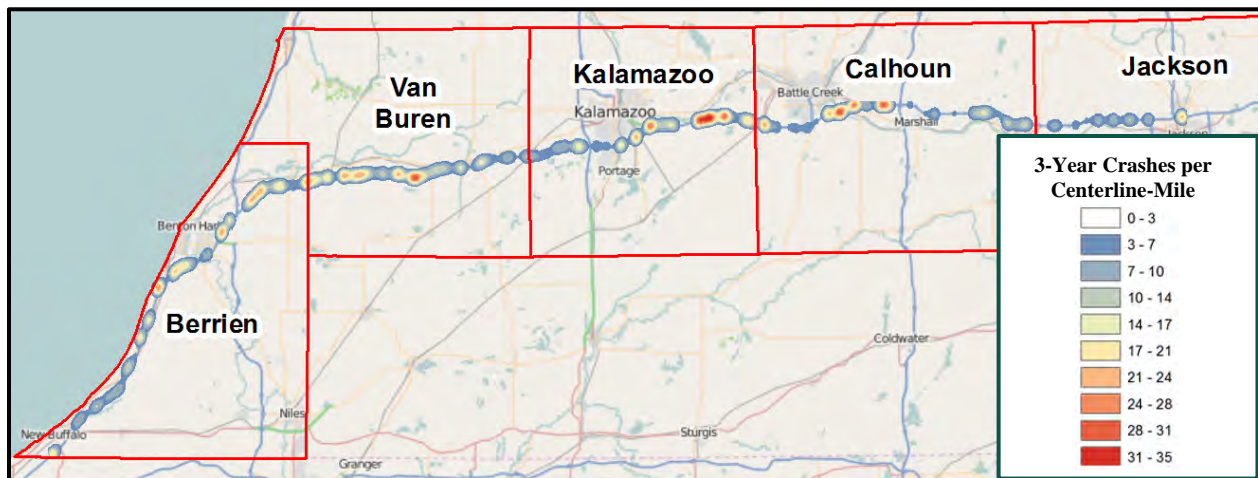
important to isolate segment crashes that occur outside of the interchange termini and create subsequent maps for use during the field reviews. For purposes of this study, non-interchange (e.g., segment) crashes were identified as mainline crashes that occurred outside of the interchange ramp termini, based on exclusion of crashes coded as interchange for the area-type code on the UD-10 crash report form. Non-interchange crash concentration maps are displayed in Figure 13(A) and (B).

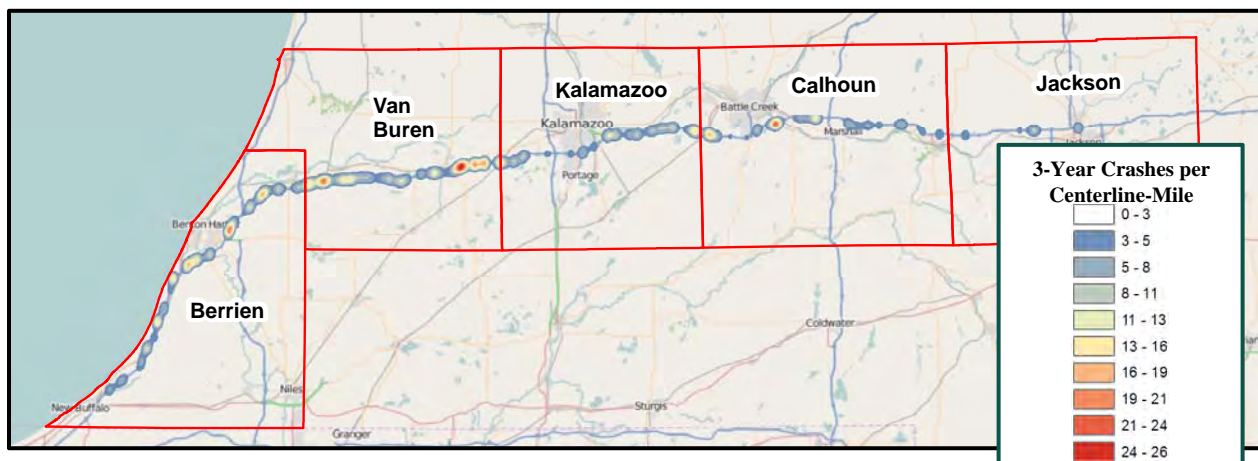
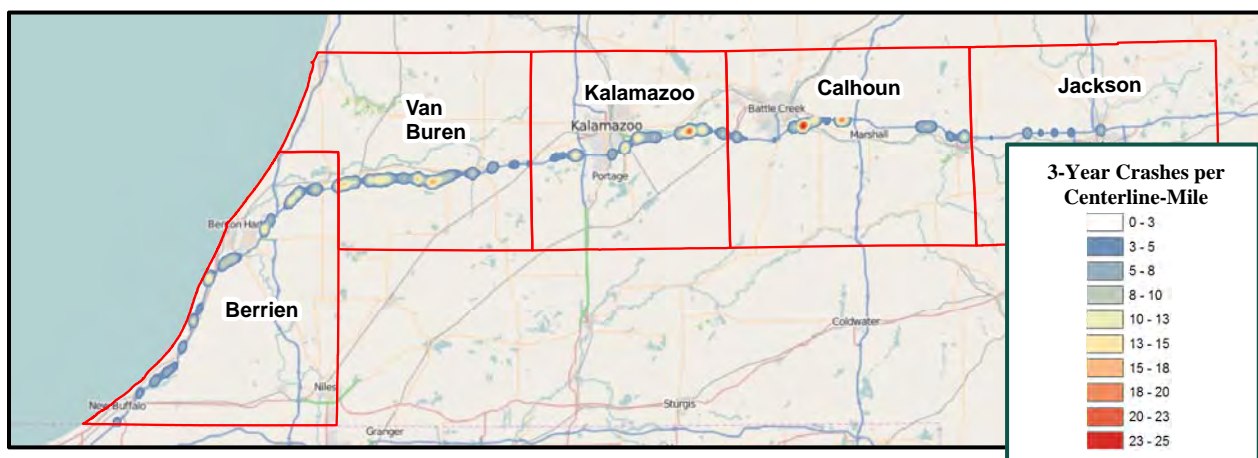
As stated previously, Van Buren County was found to have the highest winter crash rate along the study corridor, particularly in the eastbound direction. Consequently, it was of particular importance to provide a detailed crash concentration map depicting winter crashes, particularly for those occurring on non-interchange segments. Figures 14(A) and (B) present the non-interchange crashes occurring from 2012 – 2014 during the winter season, which was defined by the months of December, January, and February.

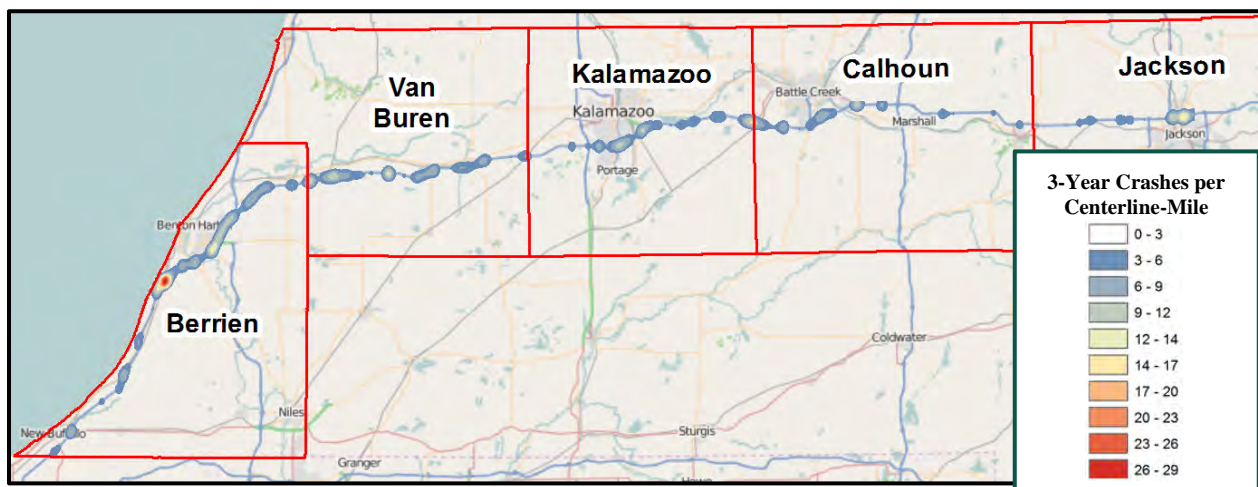
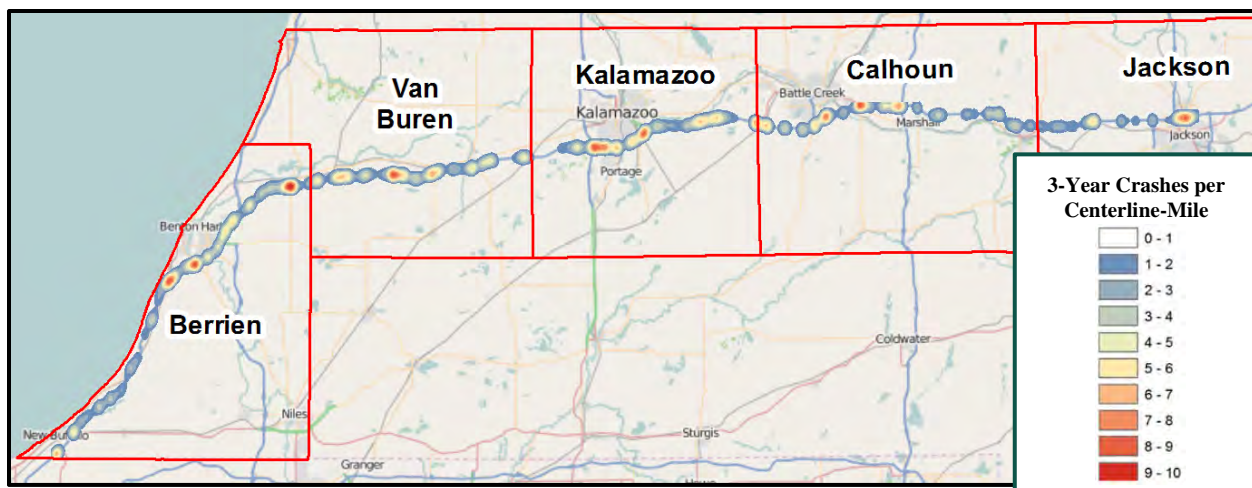
Due to the heavy commercial vehicle volumes along the corridor, it was also deemed necessary to review areas with high concentrations of truck/bus involved crashes. Figure 15(A) and (B) present the truck or bus involved crashes occurring between 2012 and 2014.

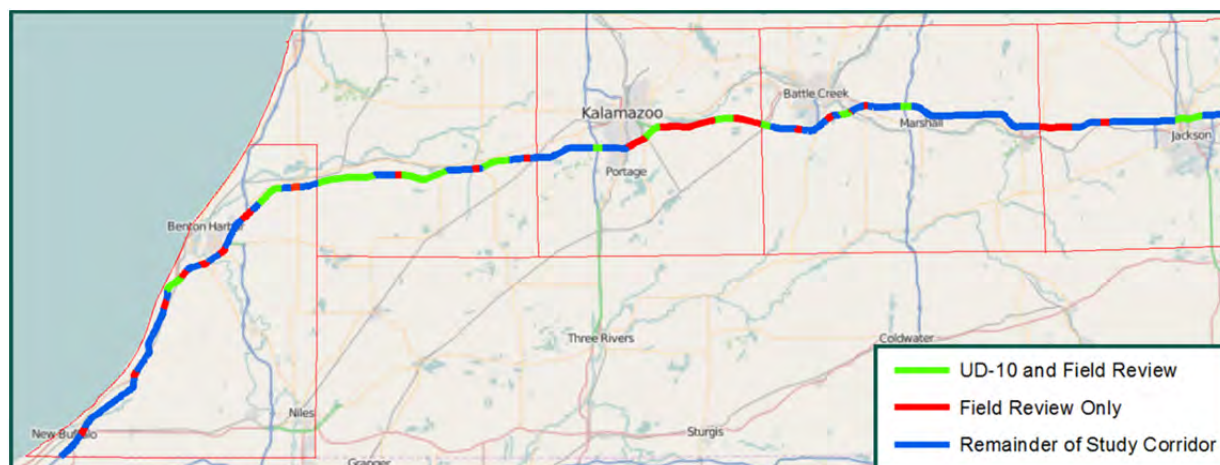
Figure 16. Overview of Safety Review Locations

The field reviews were attended by the core members of the project team, in addition to local/regional MDOT and MSP staff familiar with the corridor. The field reviews typically began with an in-office presentation of the crash concentration maps to help stimulate discussion of the primary areas for further review and possible causal factors. Anecdotal comments received prior to the meetings from local MSP and MDOT staff familiar with the corridor were also reviewed for additional insight. After identification of specific areas for further field inspection, the team then traveled the corridor and performed the on-site field reviews. Following the field reviews, the team then returned to the office for follow-up discussion to develop conclusions and possible crash countermeasures. These post-review wrap-up sessions provided substantial direction towards subsequent review of UD-10 crash reports for the primary areas of high crash concentration along corridor, which is described in the paragraphs that follow. Figure 16 provides an overview of the site review locations on the study corridor.

A subsequent review of more than 2,000 UD-10 crash report forms was performed for selected areas along the study corridor that were identified during the field reviews as areas warranting further investigation. The UD-10 reviews were intended to identify specific crash trends and recommend appropriate countermeasures. Ten freeway segments and two interchanges were selected for this detailed evaluation. Deer crashes were excluded from this review. The selected interchanges and segments for the UD-10 crash report review are summarized in Table 12 and displayed in Figure 16.

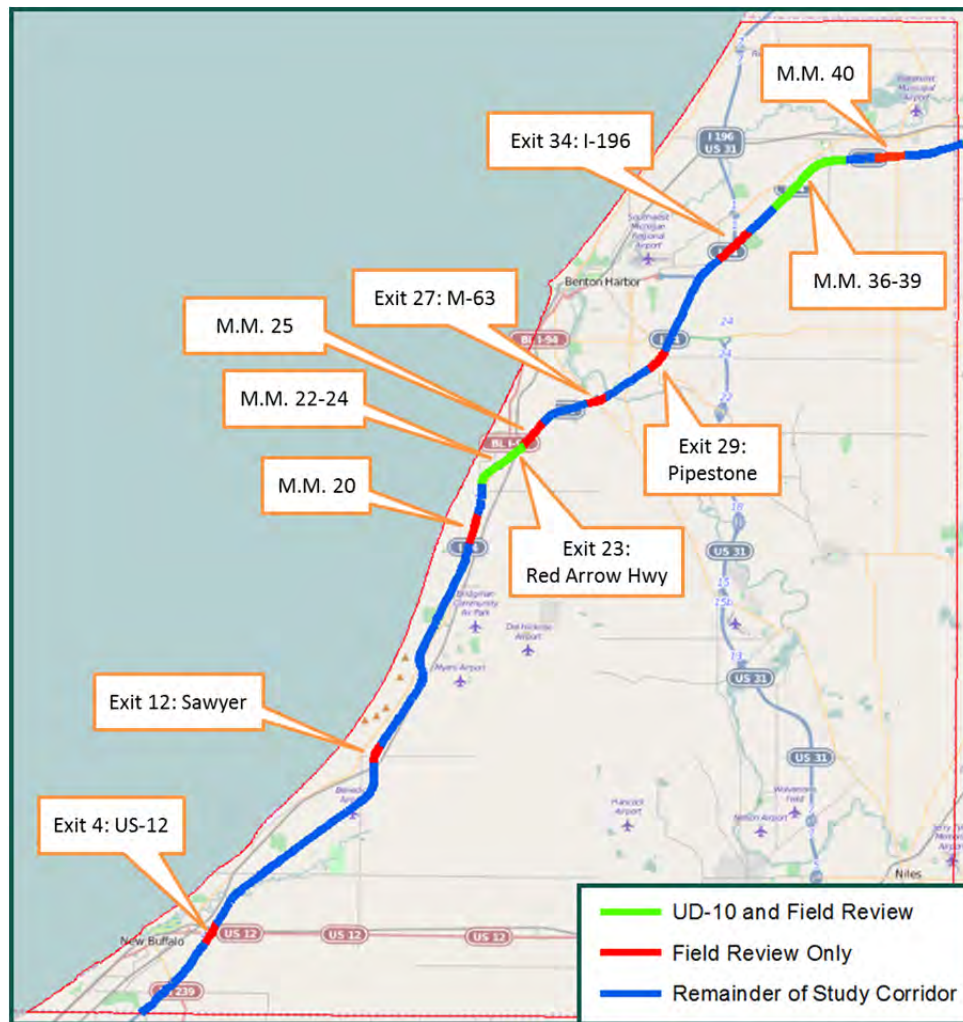
Figure 17. Safety Review Locations – Berrien County

Figure 17 presents a map of the reviewed locations within Berrien County.

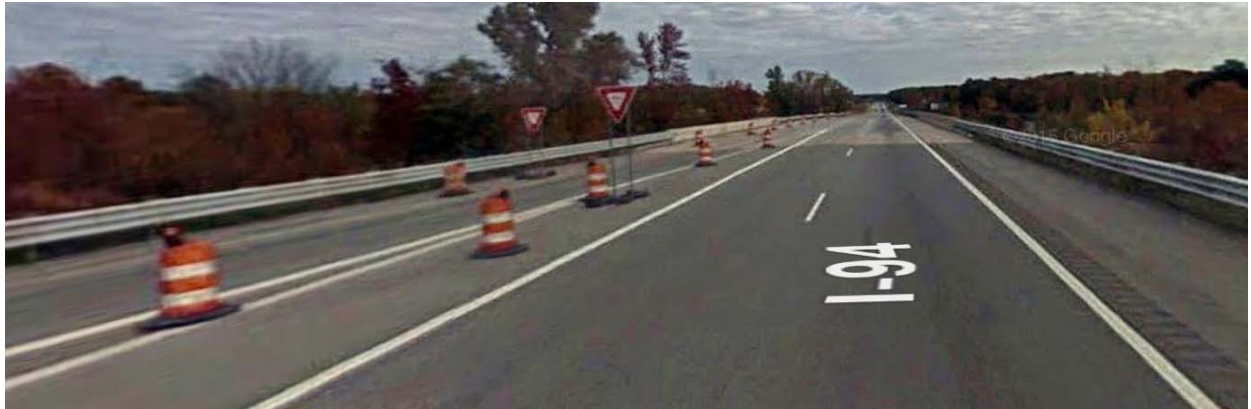
Eastbound I-94 at Entrance Ramp from Westbound US-12 (Exit 4)

control speeds and alleviate overturns. Extension of the acceleration lane or ramp reconfiguration may also be a potential safety countermeasure.

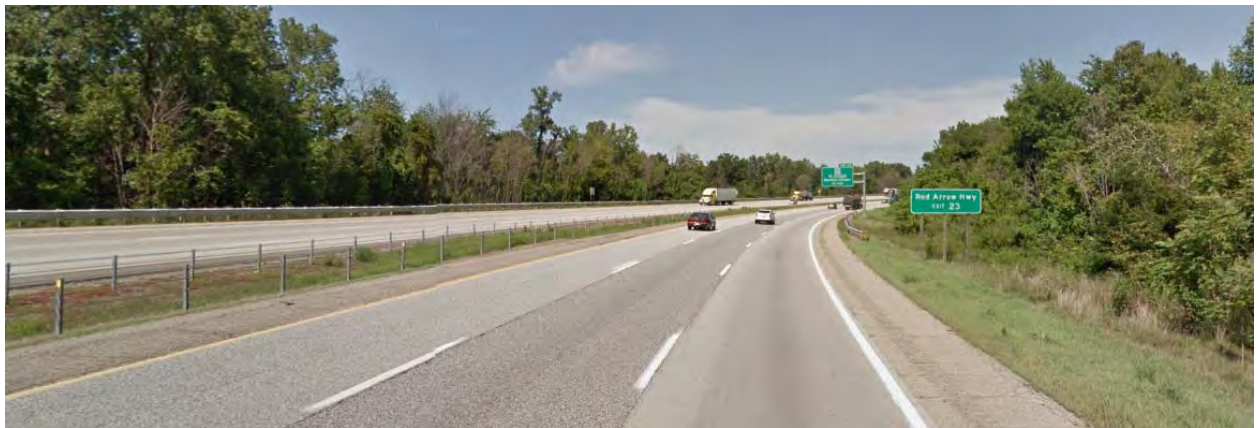
- **Potential Countermeasures:** MDOT has resurfacing projects programmed for 2016 (westbound) and 2017 (eastbound) that will include the Puetz Road curve. In addition to the resurfacing, which should improve pavement surface friction, these projects will also include superelevation improvements to increase the curve design speed and shoulder widening to improve the recovery

area for vehicles. The recently installed median cable barrier will help prevent the often severe cross-median type crashes that had previously occurred in the area. Property damage crashes may also be reduced if the cable median barrier is relocated away from the eastbound shoulder through the Puetz Road curve. However, cable barrier relocation may not be possible in the interchange area due to the reduced median width. To combat winter weather safety issues, this section may benefit from installation of an environmental sensor station and corresponding ITS signs/devices to alert motorists when poor weather and/or surface conditions are predicted. Additionally, a “living snow fence” consisting of dense installation of trees and other vegetation, similar to that proposed between Exits 46 and 56, may help reduce the occurrence of blowing and drifting of snow across open sections of the freeway. Advanced salting techniques, including brine or other chemicals or methods, may help improve winter road conditions along this section. Although a long-term implementation strategy, improvements to the freeway lighting, particularly at the interchange, may provide additional safety benefits.

Eastbound I-94 at Puetz Road Curve

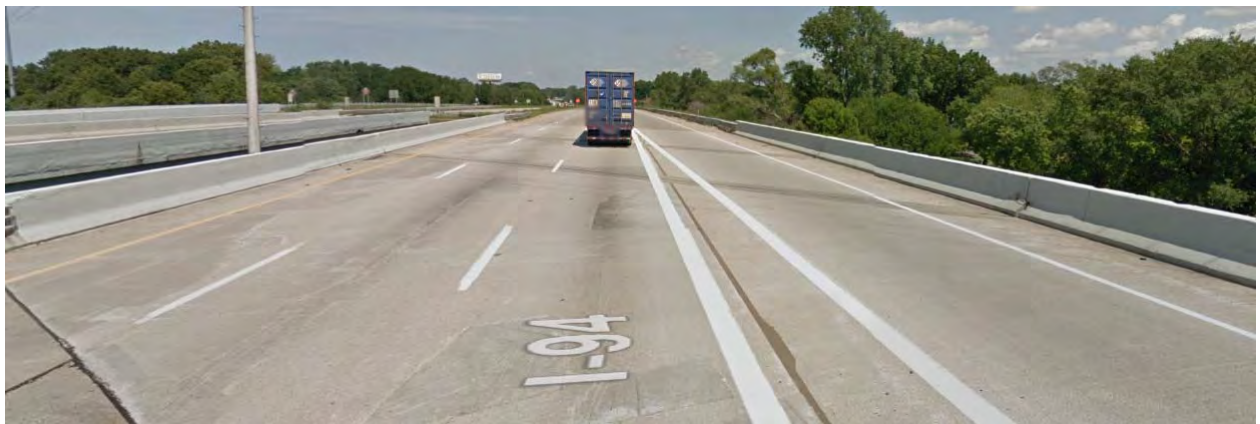
Eastbound I-94 Entrance Ramp from Red Arrow Highway (Exit 23)

- **Mile Marker 25:** Crashes continue to persist well downstream of the eastbound entrance ramp from Red Arrow Highway, possibly due to truck acceleration issues to the vertical upgrade and the horizontal curve near mile marker 25. Anecdotal observations also suggested that there may potential concrete pavement icing issues in this area.

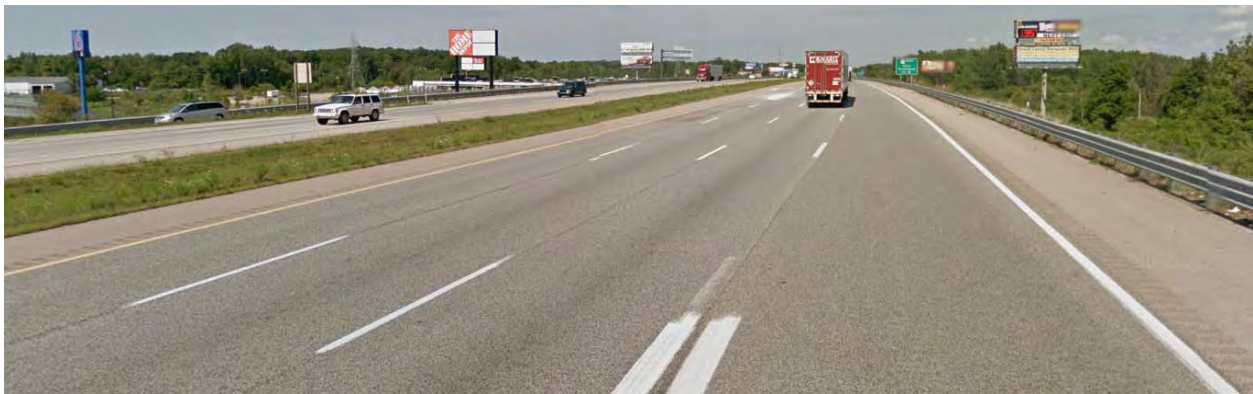
Eastbound I-94 Entrance Ramp from Pipestone Road (Exit 29)

- **Exit 29 (Pipestone Road):** The eastbound entrance ramp involves both a vertical upgrade and horizontal curve with an abrupt merge taper. These collectively create acceleration issues, particularly for trucks. The eastbound auxiliary lane extension to the next interchange (Napier Road) is a possible medium to long term improvement.

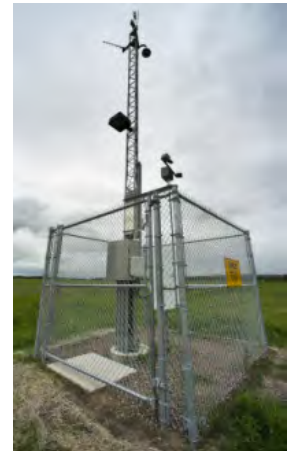
Envir. Sensor Station

- Potential Countermeasures: An environmental sensor station is proposed for installation nearby at the I-196 interchange in 2016. This station will provide real-time weather data, along with pavement condition and forecasting data for the area, which should help improve winter maintenance and other safety and operational aspects along this segment. The environmental sensor data may also be used in conjunction with variable speed limit signs or other ITS signs/devices to better alert motorists of changing weather and/or pavement conditions. Additionally, a “living snow fence” consisting of dense installation of trees and other vegetation (similar to that proposed between Exits 46 and 56), may help reduce the occurrence of blowing and drifting of snow across open sections of the freeway. Targeted high friction surface treatments are recommended to treat area of low pavement friction within this segment. Advanced salting techniques, including brine or other chemicals or methods, may help improve winter road conditions along this section. Lengthening the acceleration and deceleration lanes at the Friday Road interchange is also recommended to help control crashes associated with the freeway/ramp transition. Although a long-term implementation strategy, improvements to the freeway lighting, particularly at the interchange, may provide additional safety benefits. Relocating the cable median barrier away from the eastbound shoulder through the Friday Road curve should reduce the occurrence of median barrier collisions, while still inhibiting cross-median crashes.

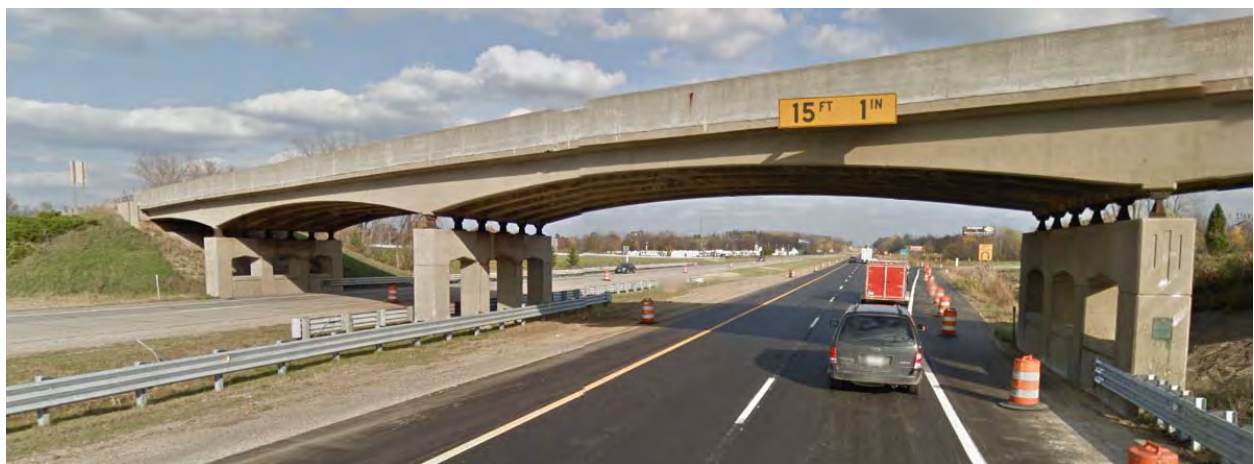
Eastbound I-94 Exit Ramp at Exit 39 (Friday Road)

- **Mile Marker 40 (Hennesy Hill):** This area includes a steep upgrade/downgrade eastbound/westbound between Exits 39 and 41. Icing has been noted as an issue, particularly for the westbound concrete pavement on the steep downgrade. This may be a good candidate for a high friction treatment in the westbound direction. The steep vertical upgrade in the eastbound direction may also present potential climbing issues for trucks entering from Friday Road.

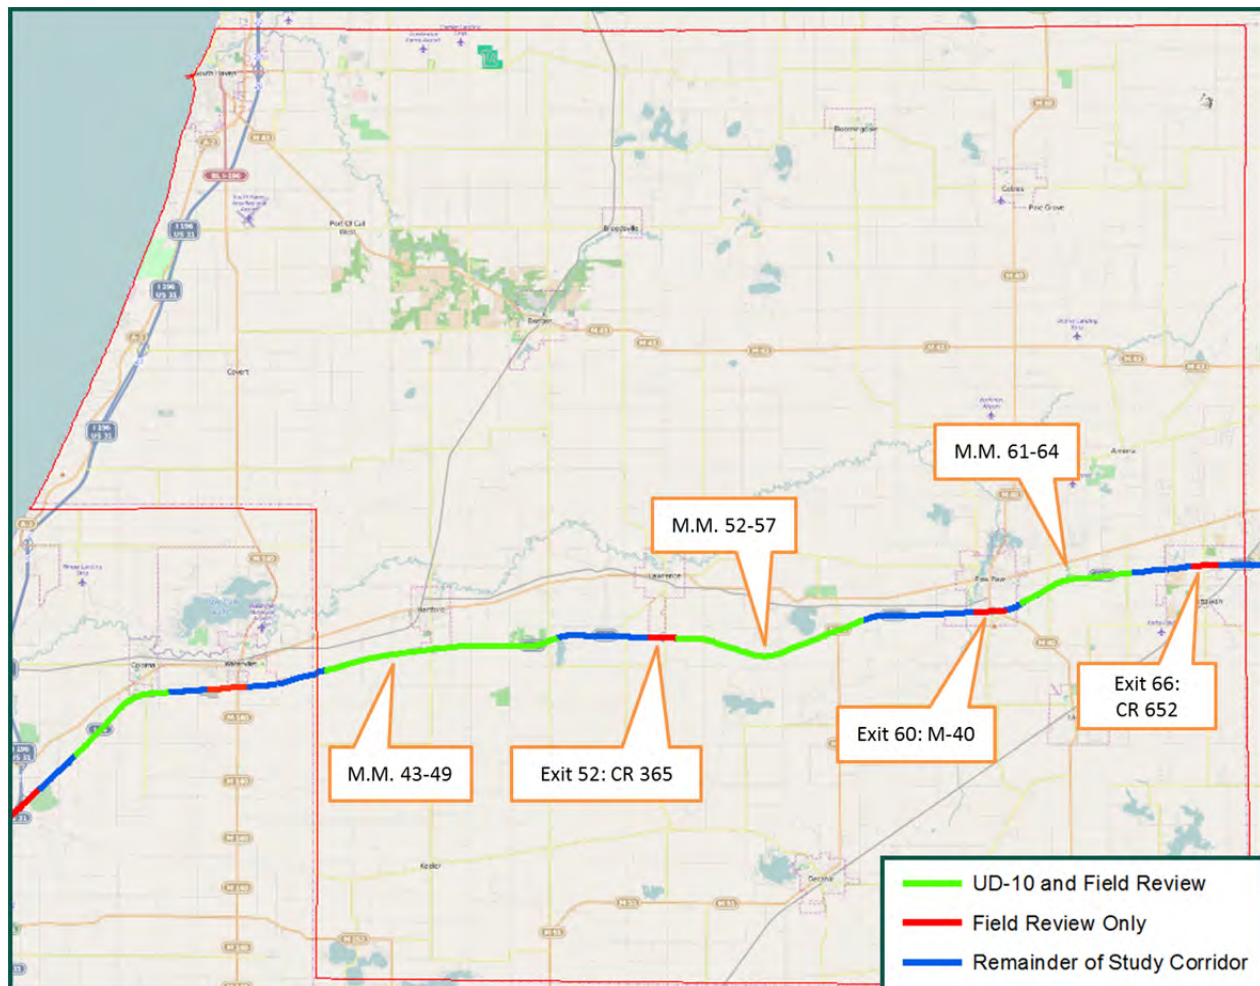
Figure 18. Safety Review Locations – Van Buren County

Figure 18 presents a map of the reviewed locations within Van Buren County.

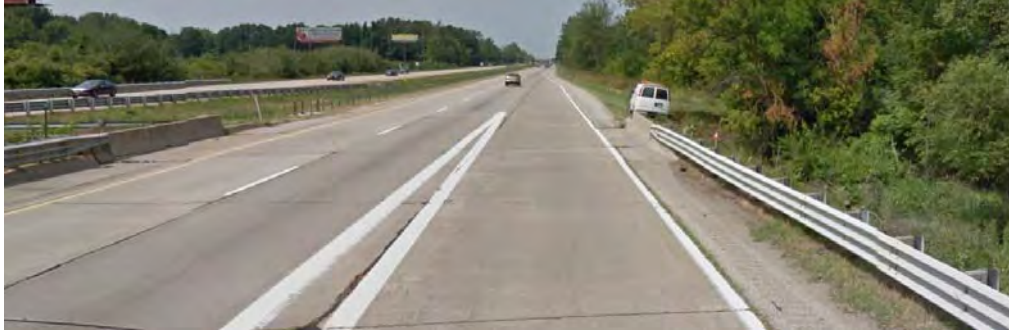
Entrance Ramp to Westbound I-94 from Exit 46 Approaching Pine Creek Bridge

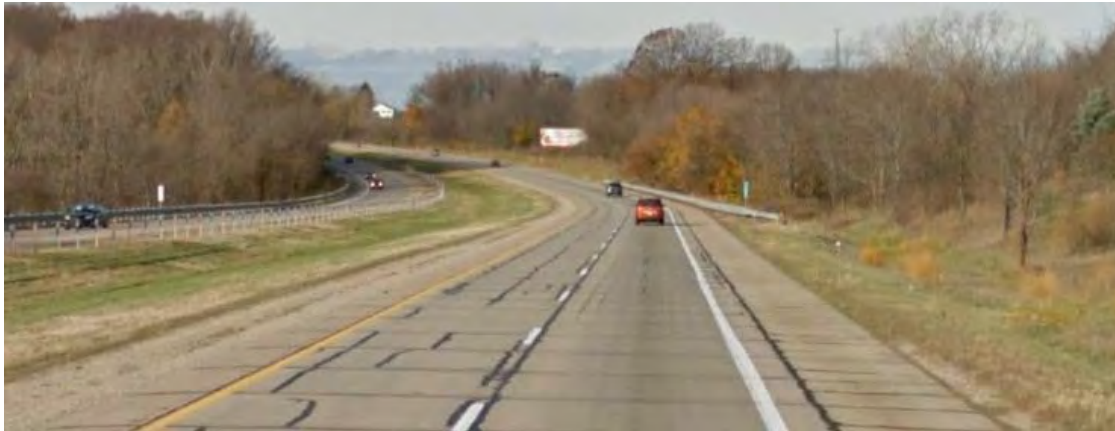
Westbound I-94 near Mile Marker 49

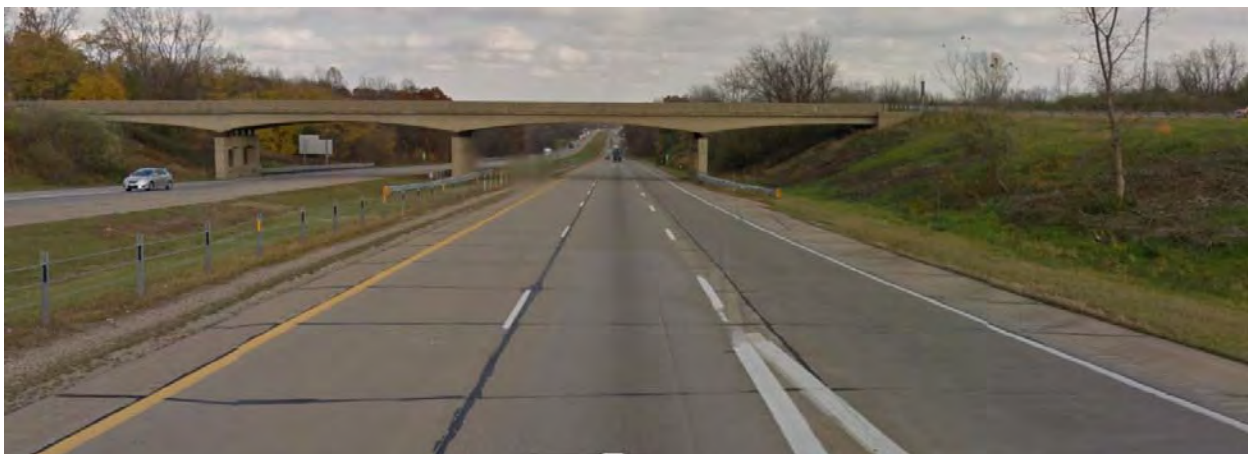
Entrance Ramp to Eastbound I-94 at Exit 52 (CR 365)

- **Exit 52 (CR 365):** Eastbound I-94 includes substantial vertical downgrade near the entrance ramp leading into a bridge underpass. This may be a suitable location for high friction surface, which is particularly effective during winter road conditions.

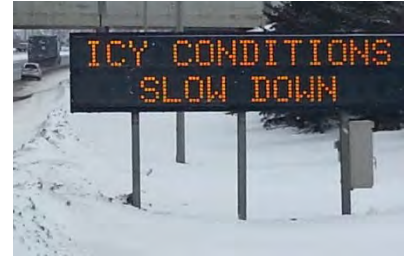
Dynamic Message Sign (Small)

- **Potential Countermeasures:** This area will fall between two proposed environmental sensor stations proposed at Exits 46 and 60, which should help improve winter maintenance and subsequent safety and operational impacts, particularly if this data is used along with ITS signs/devices to alert motorists of changing weather and/or pavement conditions.
