**JACKSON AREA COMPREHENSIVE TRANSPORTATION STUDY (JACTS)
TECHNICAL ADVISORY COMMITTEE**

Evaluation of the I-94 Corridor from the Indiana State Line to US-127 South

FINAL REPORT

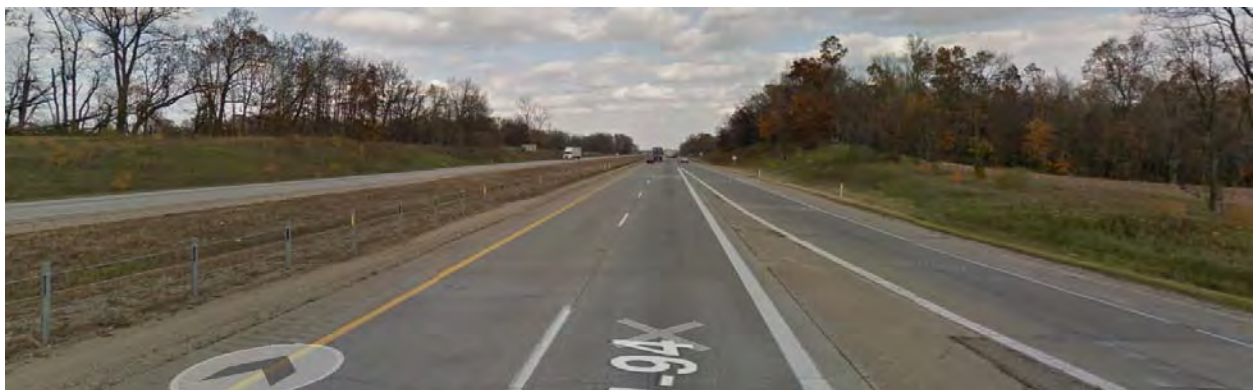
Additionally, a large tree installation project (“living snow fence”) to reduce blowing and drifting of snow across the freeway is proposed to occur in 2019 between Exits 46 and 56. Advanced salting techniques, including brine or other chemicals or methods, may help improve winter road conditions along this section. Resurfacing in the westbound direction in 2015 and eastbound direction in 2017 in the eastern portion of this section will correct issues with low pavement friction in this area. Pavement friction may be improved in other areas by using localized high friction surface treatments. The eastbound reconstruction will also include shoulder widening and superelevation adjustment. The M-51 interchange may also benefit from lengthening of the acceleration and deceleration lanes to help control crashes associated with the freeway/ramp transition.

Eastbound I-94 Entrance Ramp from Exit 56 (M-51)

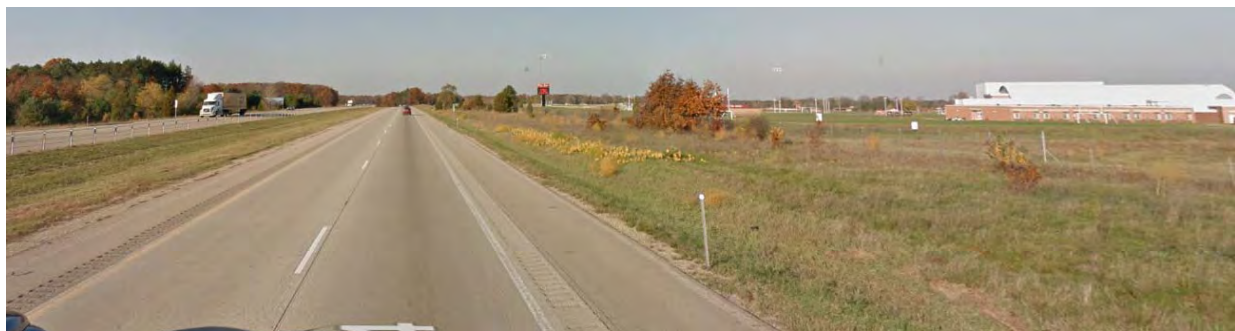
Westbound I-94 and Adjacent Roadside near Paw Paw High School (Mile Marker 63)

- **Potential Countermeasures:** The nearby environmental sensor station proposed for installation near Exit 60 in 2016 will help improve prediction of winter weather and pavement surface conditions and alleviate associated safety and operational issues, particularly if this data is used along with ITS devices to alert motorists of changing weather and/or pavement conditions. Advanced salting techniques, including brine or other chemicals or methods, may help improve winter road conditions along this section. The area near Paw Paw High School may be another suitable location for a living wind barrier, which would include trees and other vegetation planted adjacent to the corridor to block blowing snow. Incidental collisions with the cable median barrier may be reduced by relocating the barrier further away from the shoulder in the areas where crashes frequently occur.

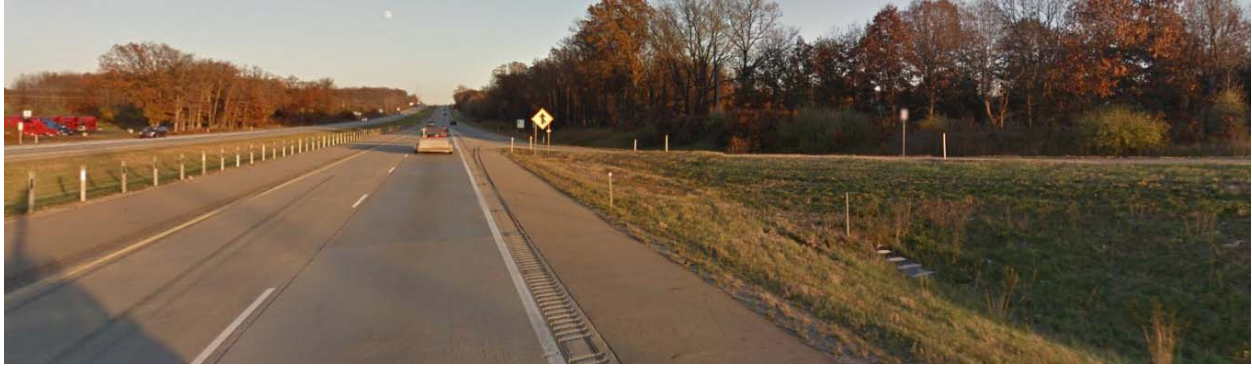
Eastbound I-94 Entrance Ramp from Exit 66 (CR 652)

- **Exit 66 (CR 652):** Safety issues were noted for truck entering the freeway at the eastbound entry ramp, due to the abrupt merge caused by the relatively short tapered acceleration lane. Lengthening the acceleration lane may help control merging-related crashes. Several median barrier strikes, possibly caused by merging vehicles, were noted in the area immediately beyond the ramp terminus. Collisions with the cable median barrier may be reduced by relocating the barrier further away from the shoulder. Trucks frequently park along the eastbound entrance ramp, which may further contribute to these safety issues.

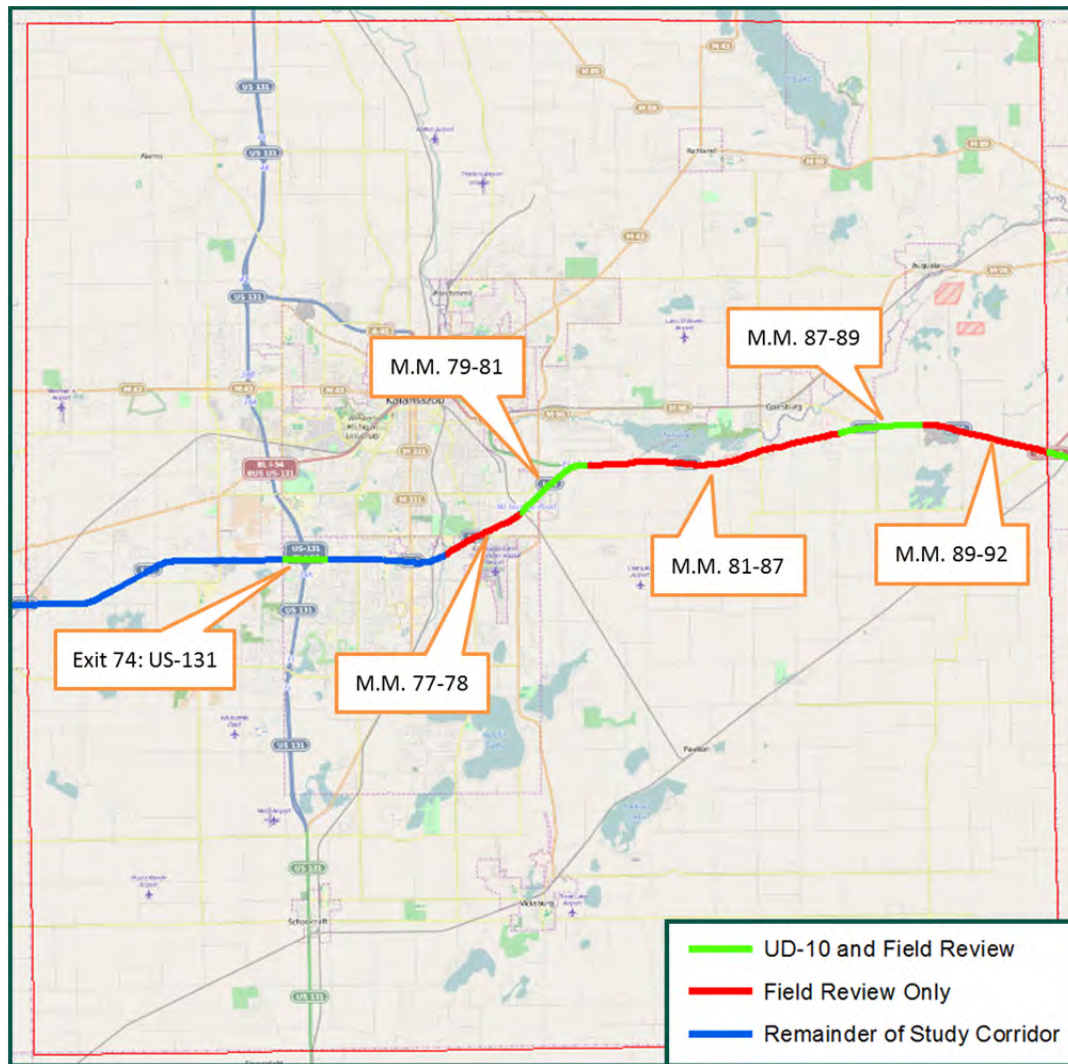
Figure 19. Safety Review Locations – Kalamazoo County

Figure 19 presents a map of the reviewed locations within Kalamazoo County.

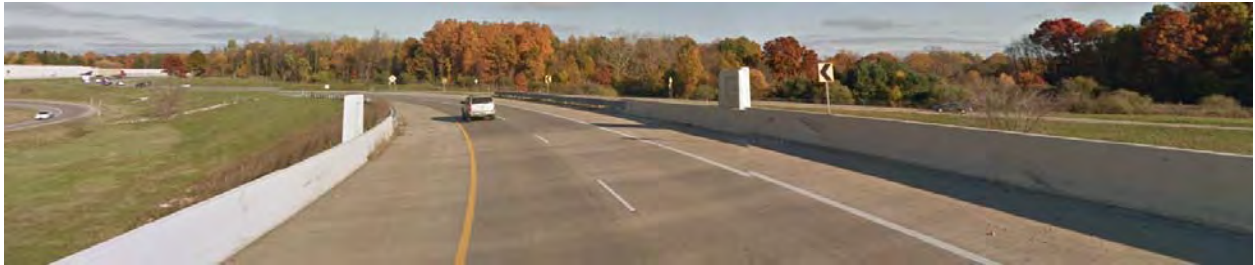
- Potential Countermeasures: To help control ramp speeds, MDOT recently installed advisory speed and curve warning signs for Southbound US-131 to Eastbound and Westbound I-94 ramp traffic, including lane assignment arrows overlays, speed advisory warning to guide signs, chevrons, and reflective post sheeting. However, additional signing and delineation through this curve is recommended to help further control speeds. Enhanced roadside delineation will be provided throughout the interchange as a part of corridor signing upgrades in Kalamazoo County in 2016. It may eventually be necessary to provide lighting at this interchange to help reduce nighttime crashes. In addition, a high friction surface project, which includes the Southbound US-131 to I-94 ramp, is scheduled for 2016. This interchange may also benefit from an environmental sensor station, which would help improve winter maintenance and subsequent safety and operational impacts, particularly if this data is used along with ITS devices to alert motorists of changing weather and/or pavement conditions. Advanced salting techniques, including brine or other chemicals or

Southbound US-131 Ramp to Eastbound I-94

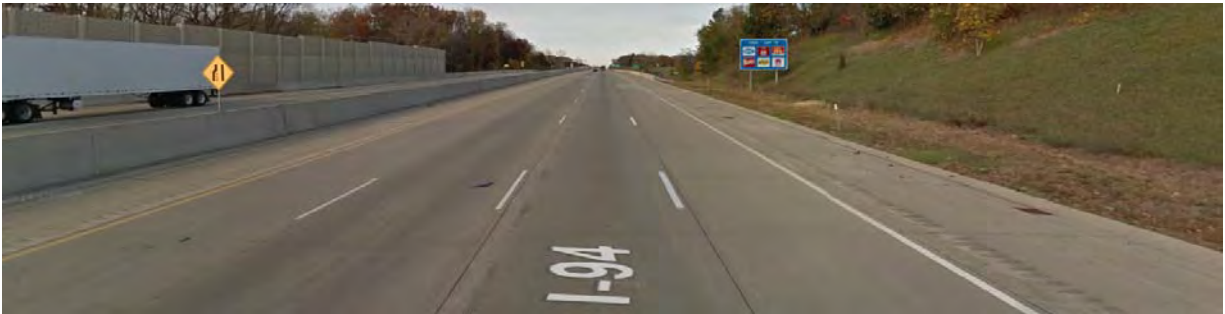
Westbound I-94 beyond Southbound US-131 Ramp Terminus

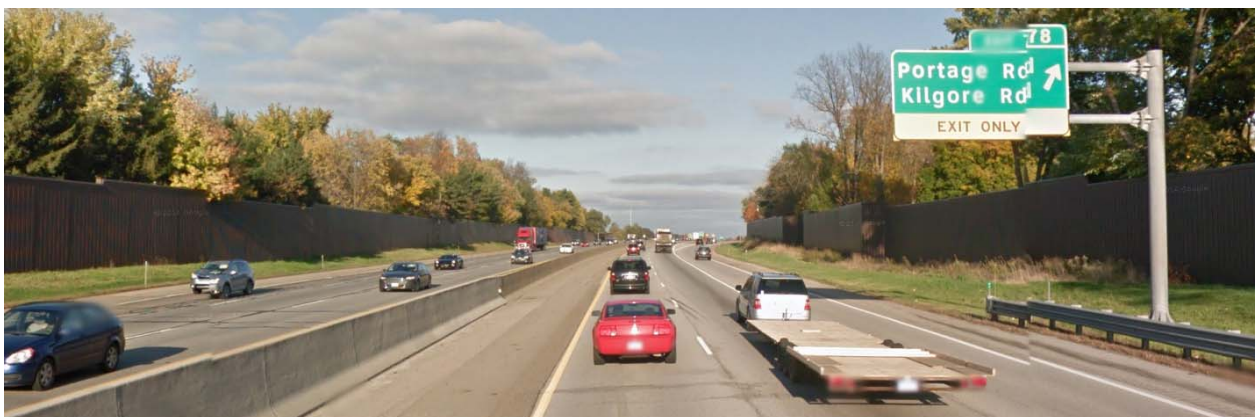
Eastbound Approaching Exit 78 (Portage Road)

- **Mile Marker 77-78 (including Portage Road Interchange [Exit 78]):** Safety issues may exist due to the unusual condition where the I-94 eastbound right lane becomes the Portage Road exit ramp. MDOT has installed “Exit Only” pavement markings and will be installing a large cantilever sign to inform drivers of the pending exit ramp and subsequent lane drop. Also, the low friction on the new concrete pavement between Oakland and Lovers should be reviewed. The eastbound entrance ramp from Southbound Portage Road has a relatively short acceleration lane. It is recommended that MDOT review the current design to determine if the lane can be lengthened into the northbound Portage Road entrance ramp.

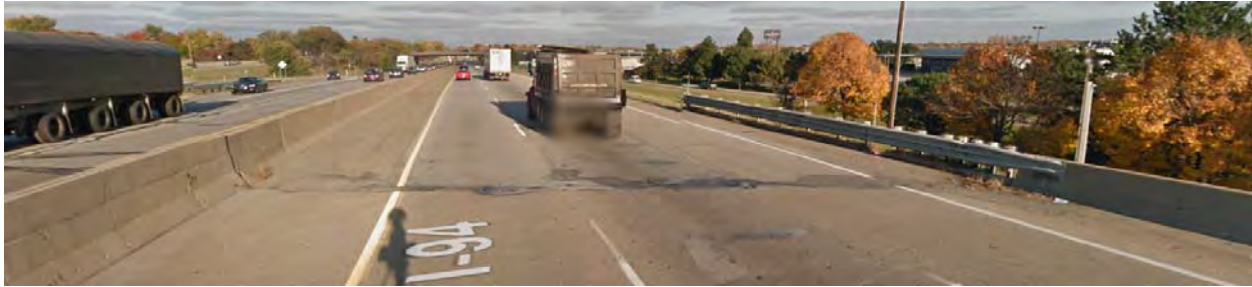
Eastbound Entrance Ramp from Southbound Portage Road

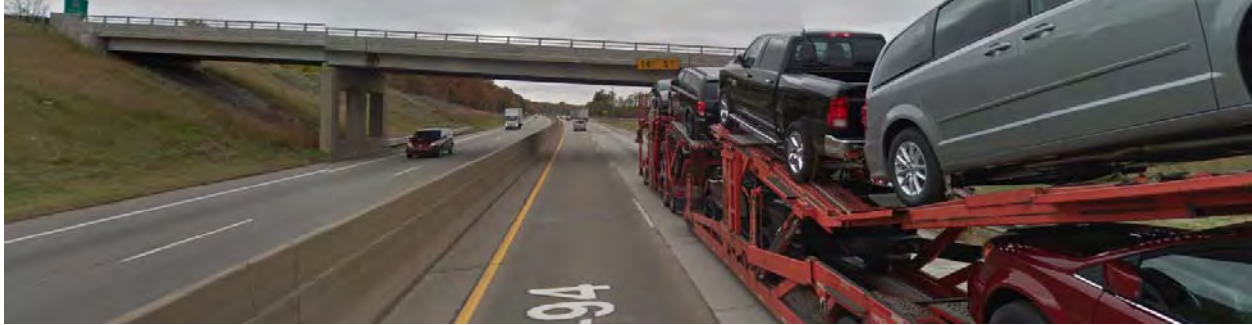
I-94 Westbound Approaching 35th Street Bridge

- **Mile Marker 81-87 (including 35th Street Interchange [Exit 85]):** Similar to mile marker 79-81, the concrete median barrier and limited shoulder creates queuing after a median-side collision occurs, contributing to secondary crashes at the back-of-queue. Emergency post-crash pull-off sites are planned for mile marker 82 westbound and mile marker 83 eastbound to help improve the efficiency of crash clearance and alleviate the residual operational and safety issues. Horizontal and vertical curvature is present near Exit 85, which likely contribute to the safety issues. However, there is little opportunity for geometric improvements through the horizontal curve (i.e., increase superelevation) without raising 35th Street bridge, which has a posted 14'5" underclearance.

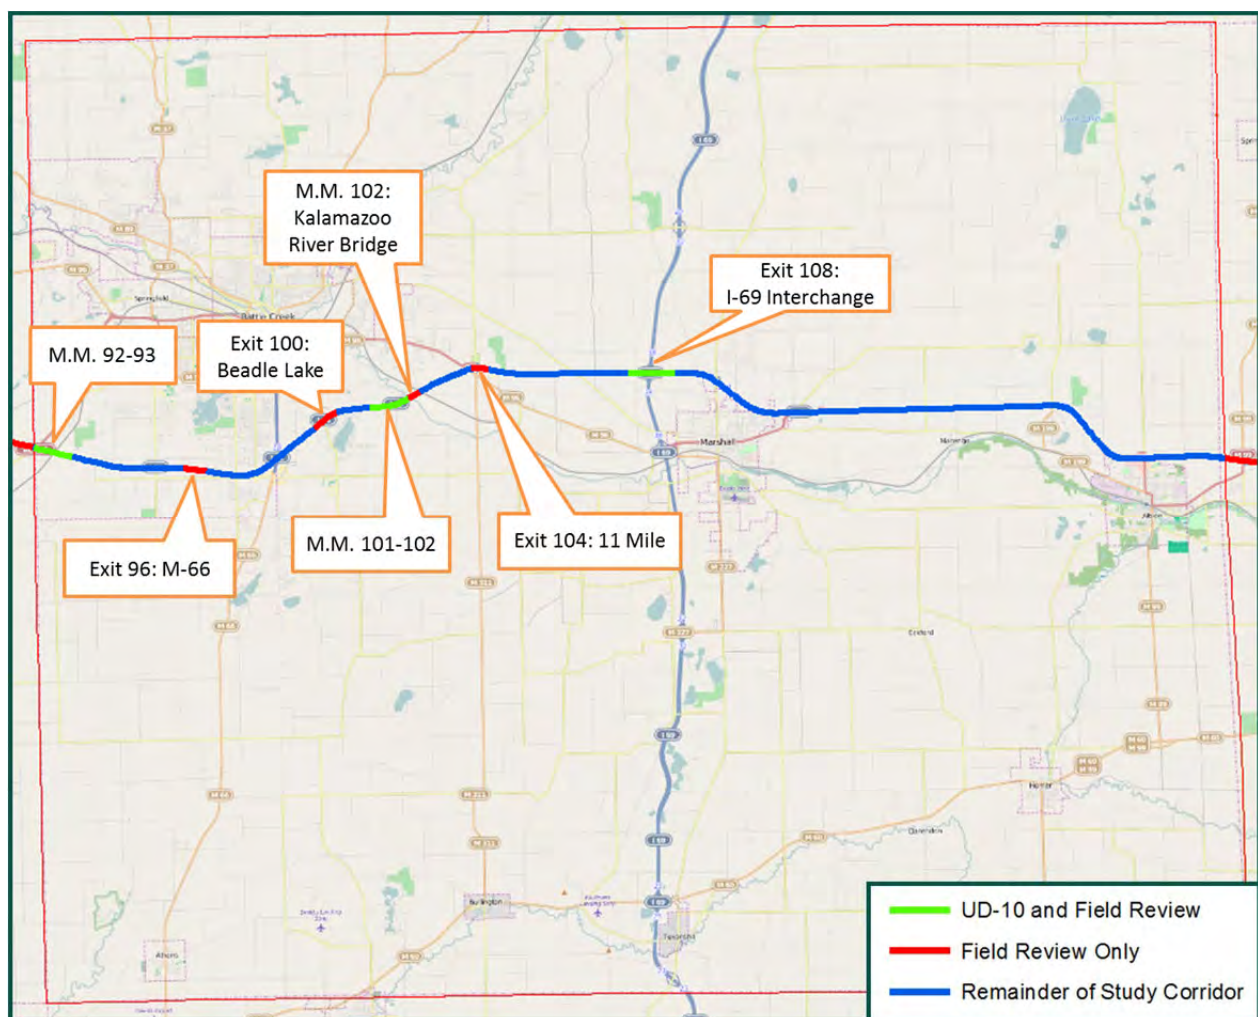
Figure 20. Safety Review Locations – Calhoun County

Figure 20 presents a map of the reviewed locations within Calhoun County.

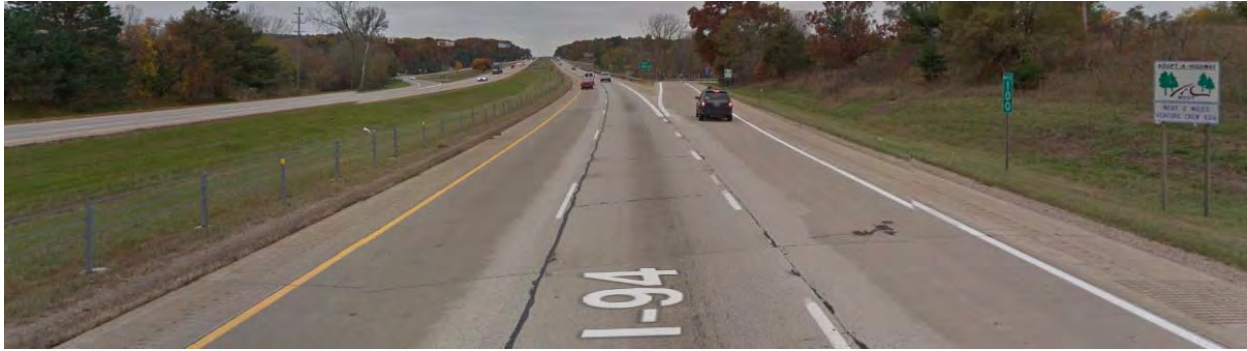
- **Exit 100 (Beadle Lake Road):** This interchange contains unfavorable geometry near the exit and entry ramps. The eastbound entrance ramp has a substantial horizontal curve near the merge taper. The westbound exit ramp has sight distance issues due to the ramp crest vertical curve at the ramp. In both cases, special delineation should be utilized to better inform drivers of impending hazards.

I-94 Westbound Approaching Exit Ramp to Beadle Lake Road

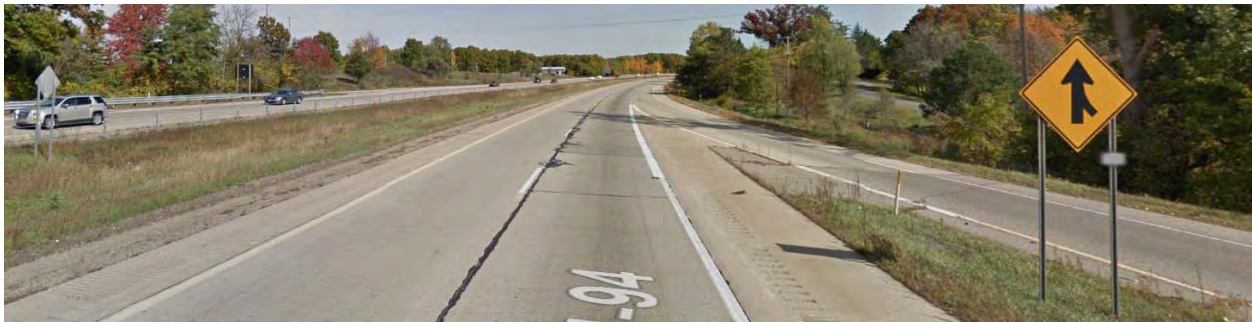
I-94 Eastbound Approaching Beadle Lake Road Entrance Ramp

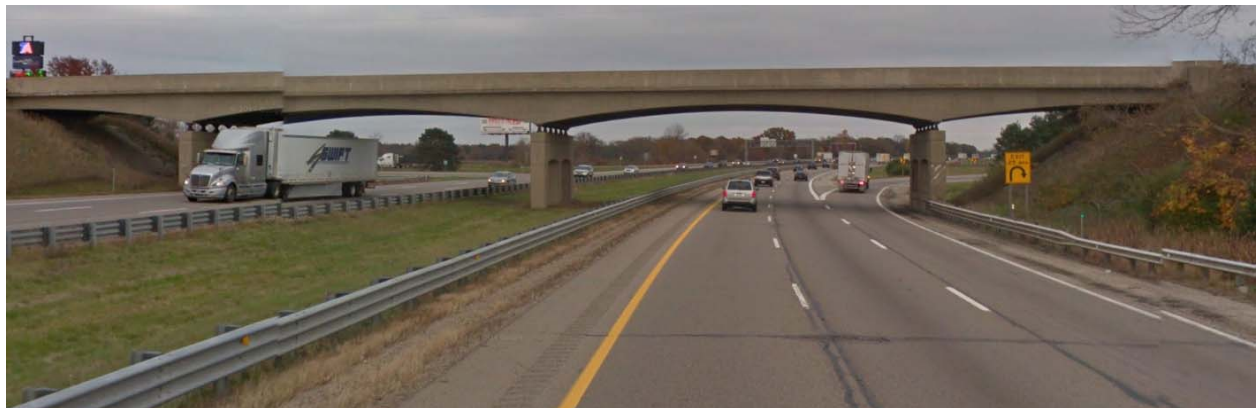
- **Exit 104 (M-96/11 Mile Road):** Both the eastbound and westbound exit ramps to 11 Mile Road have recently been extended to account for the increased traffic associated with the casino. Two truck stops also exist on the north side of the interchange. The eastbound loop ramp has tight horizontal radii and is particularly susceptible to backups. Truck rollover crashes is a major issue on the westbound entrance ramp. However, the bridge will require replacement in the event of westbound entrance ramp realignment. Cross-hatching or other delineation treatments should be implemented in the gore area. Safety improvement projects are scheduled for this interchange in 2020 to correct the superelevation difference with the mainline.

I-94 Eastbound Approaching 11 Mile Road Exit Ramp

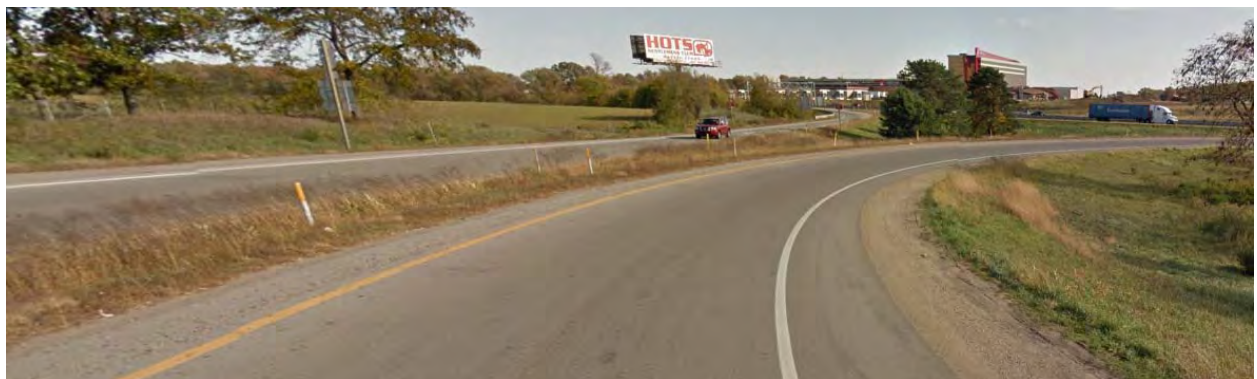
Curve on 11 Mile Road Entrance Ramp to I-94 Westbound

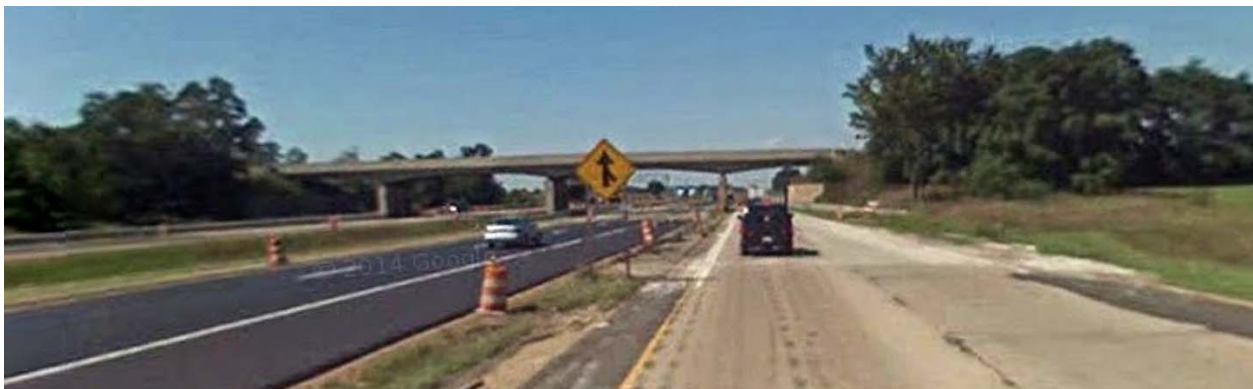
- Potential Countermeasures: A living snow fence should be considered to inhibit blowing snow. I-69 SB to I-94 Westbound presents a particularly precarious merge area between the ramp and the collector-distributor road, with the 15 Mile Road bridge abutment at the end of the merge taper, which contributes to a relatively high occurrence of side-swipe collisions. A potential long-term solution is to improve the merging area at this location, which would require reconstruction of the 15-mile Road Bridge. Furthermore, the eastbound I-94 crash attenuator at the I-69 exit ramp is struck several times each year. Delineation improvements have recently been installed within the eastbound exit gore area. Speed-related truck rollover crashes have been a longstanding problem on the loop ramps at this interchange. A subsequent signing/delineation project in late 2012 was performed to help correct this issue. This project included the addition of advisory speed signs, chevrons with reflective sheeting on posts, and truck rollover signs to all ramps. Increasing the superelevation of the loop ramps is a possible countermeasure to increase the ramp design speed. Additional enhancements to roadside delineation throughout the mainline and interchange will be performed as part of the 2016 I-94 Calhoun County signing upgrade project. An environmental sensor station is proposed to be built within the I-69 interchange in 2016, which will provide real time pavement condition data as well as support roadway condition forecasting with atmospheric sensors. This should improve winter maintenance and help alleviate weather related safety and operational issues, particularly if this data is used along with ITS devices to alert motorists of changing weather and/or pavement conditions. Advanced salting techniques, including brine or other chemicals or methods, may also help improve winter road conditions along this section. Although a long-term implementation strategy, improvements to the freeway lighting may provide additional safety benefits.

Westbound I-69 Entrance Ramp to Westbound I-94 Collector-Distributor Road

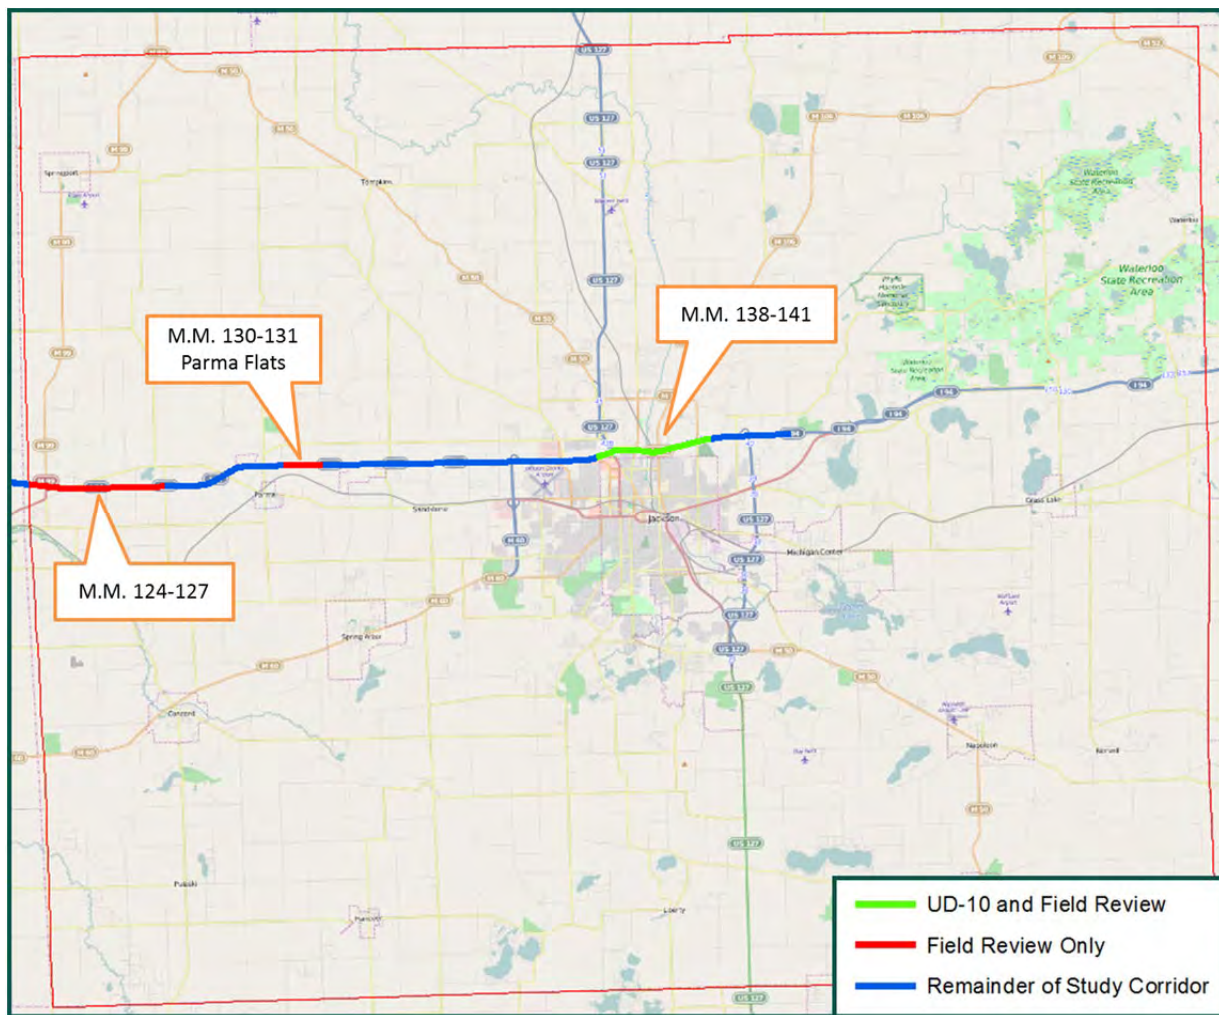
Figure 21. Safety Review Locations – Jackson County

Figure 21 presents a map of the reviewed locations within Jackson County.

Brief summaries of the findings from the Jackson County field and UD-10 reviews, including identified issues and potential recommendations, are listed as follows (underlined sections indicates that UD-10 crash forms were reviewed in addition to the field review):

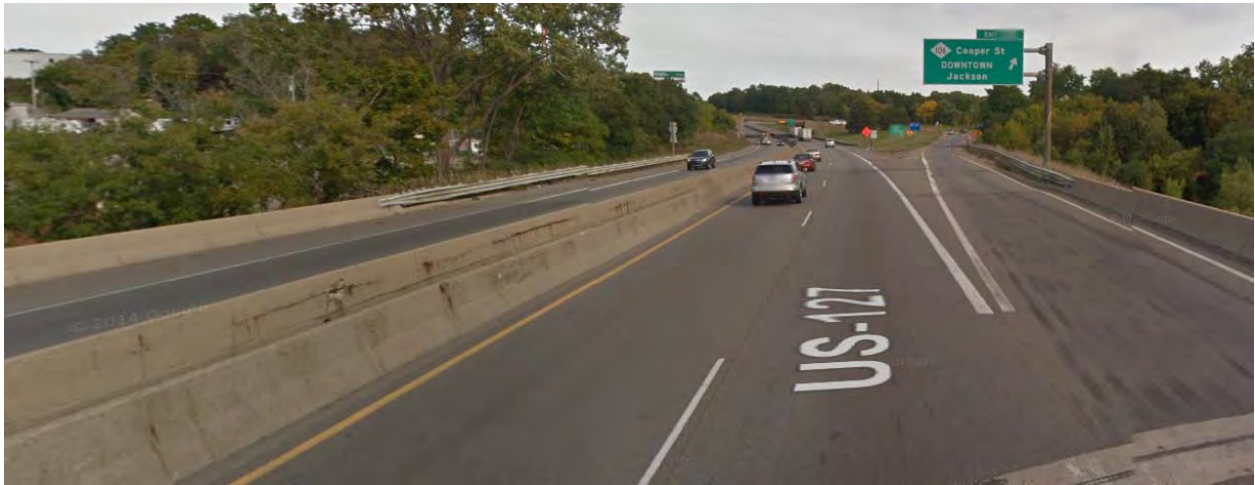
I-94 Westbound Exit Ramp to Cooper Street

- **Potential Countermeasures:** To correct many of the geometric issues, MDOT has programmed an extensive widening project planned for this section of the study corridor between 2018 and 2020. The most constrained section (Lansing Road to Elm) will be fully reconstructed and realigned to address many of the geometric issues that persist. The reconstruction work will include shifting the current I-94 alignment to the north, replacing the Grand River and Cooper Street bridge structures, adding a merge weave lane, and reconstructing the Cooper Street interchange. This project will also include rehabilitation work from M-60 to Lansing Avenue and Elm Avenue to Sargent Road and will include extending the ramp acceleration and deceleration lanes, widening shoulders,

and resurfacing the roadway. Over the past few years, the Jackson TSC staff has developed working relationships with area first responders. The TSC maintenance coordinator is on site for most incidents that occur on I-94, assisting with traffic control to keep traffic moving as safely and efficiently as possible to help reduce the occurrence of secondary crashes. This section of corridor has also experienced improved winter maintenance initiatives, including advanced deicing techniques. Freeway lighting and ITS initiatives have also been discussed for long term implementation along this section of the corridor.

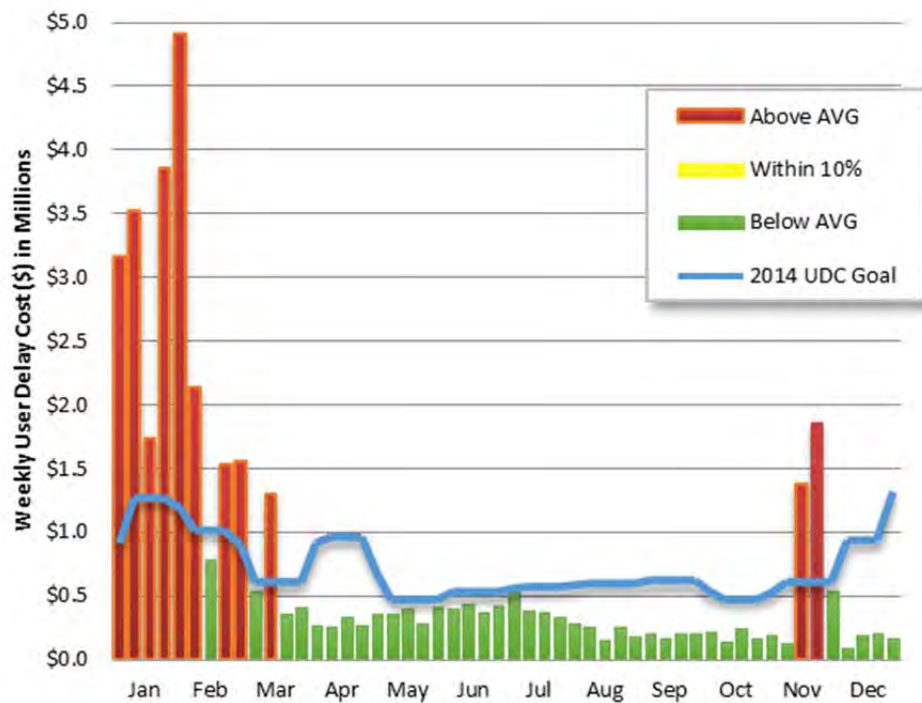
Figure 22. 2014 Southwest Region Weekly User Delay Cost

Region staff implemented Four Disciplines of Execution (4DX) as model to follow for monitoring and improving freeway operations. The 4DX process itself is a performance metric and requires an overall measurable goal, tracks efforts of what influences that goal, uses a scoreboard tracking progress, and necessitates routine discussion of the goal. In addition to the overall reliability goal, measures were created toward specific causes of congestion: work zone delays, incident management response, and winter weather impacts. The focus was on these causes of non-recurring congestion since they are more likely to be influenced in the short-term compared to high cost construction projects taking years to implement. Southwest Region weekly user delay costs for 2014 are shown in Figure 22.

The process has evolved over the years from counting instances of slow traffic from screen captures on the MDOT real-time travel information site Mi-Drive (www.michigan.gov/drive), to running delay reports directly from the speed data used on Mi-Drive. Originally, delays were monitored on I-94 but have expanded to I-196, I-69, and US-131 as well. Each year, the region sets a goal for user delay cost based on the annual averages over the prior three years. The weekly results from last year are shown in the chart. The winter of 2013-2014 played a major factor in the region's ability to achieve its reliability goals. Goals for the causes of non-recurring congestion are also data driven, which is described, as follows:

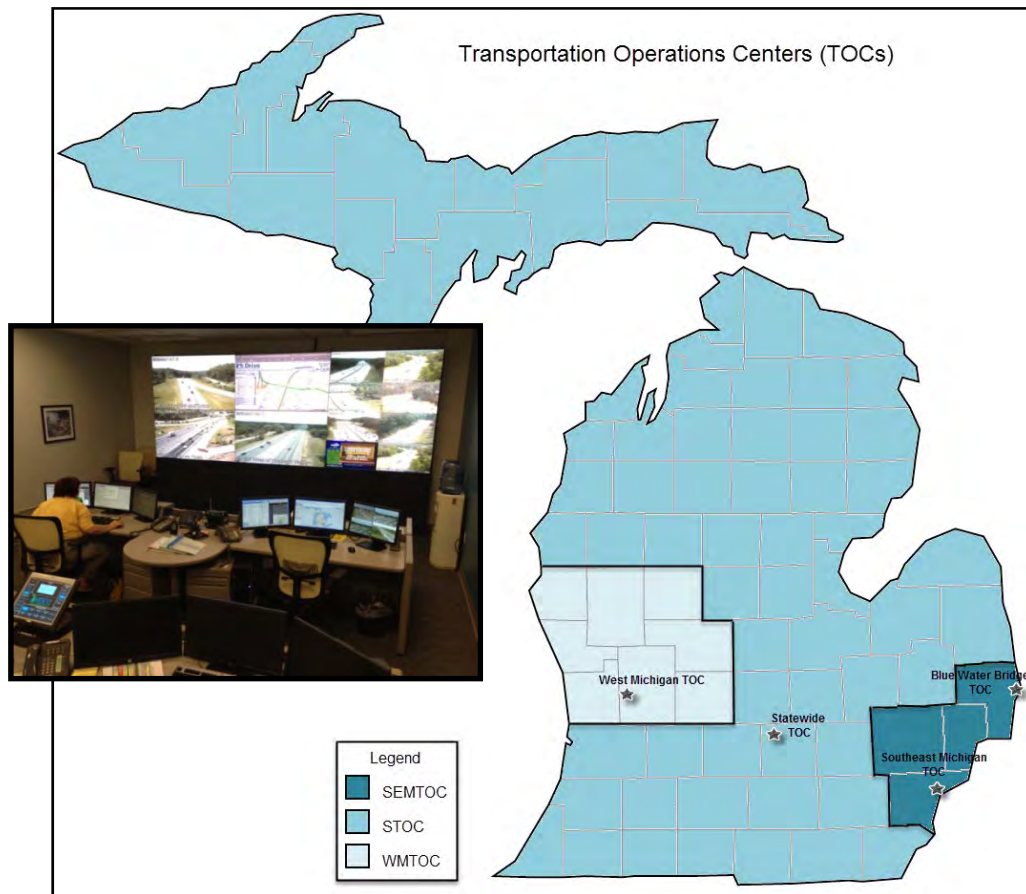
Figure 23. MDOT Transportation Operations Centers

The Michigan Department of Transportation owns and manages four Transportation Operations Centers (TOCs) which provide active operations coverage of all state roadways. The MDOT TOCs are displayed in Figure 23. Note that I-94 from the Indiana state line to the Washtenaw/Wayne County line fall under the coverage area of the Statewide Transportation Operations Center (STOC).

The STOC is a 24/7 operations center in downtown Lansing with eight full time Control Room Operators (CROs). The number of CROs working in the control room at any time can vary from one to four, depending on the time of day and day of week. The TOCs are tasked with being aware of and conveying information as appropriate for any activity that is affecting or has the potential to affect the operation of a state highway. This could be construction, maintenance activities, a traffic incident, a police incident, a house or vehicle fire, severe weather, etc. Once the CRO becomes aware of an incident that is affecting, or has the potential to affect, the safety and efficiency of our roadway system, they are responsible for conveying the information to all appropriate parties. This means they are frequently in contact with local

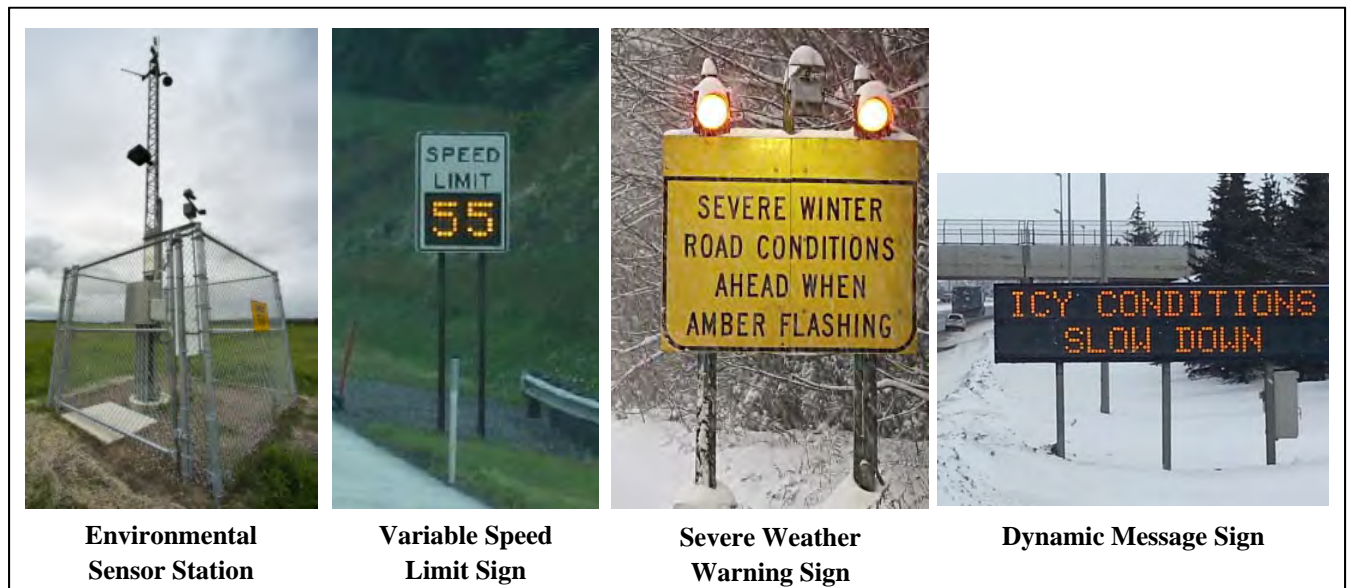
Figure 24. Examples of Potential Treatments

- Winter Weather Treatments
 - Environmental sensor stations (Figure 24a)
 - Variable speed limits (Figure 24b)
 - ITS devices providing weather-related messages (Figure 24c,24d)
 - Advanced de-icing strategies
 - Living snow fence (strategic planting of roadside vegetation)
- Pavement Surface Treatments
 - Resurfacing
 - High friction course
- Visibility Enhancements
 - Signing

- Pavement markings
- Delineation
- Lighting
- Geometric Improvements
 - Cable barrier relocation
 - Ramp extension or realignment
 - Shoulder widening
 - Increased superelevation
- Congestion Management
 - Crash investigation pull-off site
 - Courtesy patrol
 - Incident management improvements
 - ITS devices providing queue warning messages (Figure 26c,26d)
 - Add third lane
